# Improving Bearing Life in Wind Turbine Mainshafts

**Zachary Broadbent**  
Application Engineer – Wind

In March 2011, the first Timken 230/600 Wear-Resistant SRB with Diamond Like Carbon (DLC) coatings on the rollers was installed into a GE 1.5MW turbine at a wind farm in New Mexico. Since its installation, the bearing was inspected twice, and the bearing was determined to be in good condition each time. With only light debris damage and no visible issues, the bearing remained in service. In 2018 this bearing was removed after seven years of service as the turbine was taken offline for non-bearing related issues. The bearing was then inspected by Timken following its return.

Similarly, a 230/600 Wear-Resistant SRB was removed from another turbine as part of a repower project following a service life of over 10 years. This SRB was installed in March of 2011 at a wind farm in Oklahoma and was removed from service in early 2021. This bearing also underwent in-service inspections in 2015 and 2017, and then a final detailed inspection in 2021 following its removal from service. The positive results of both post operation inspections are detailed below, demonstrating the benefit of t

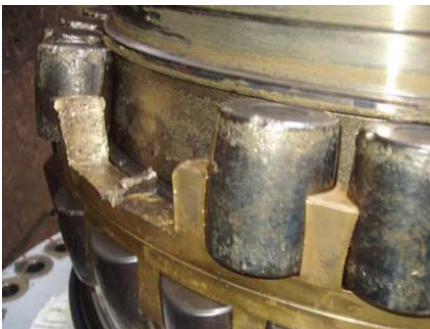
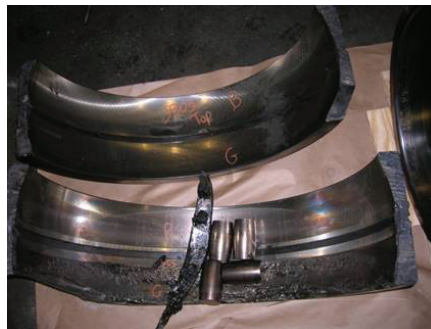
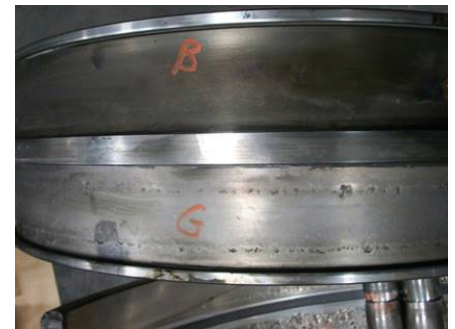
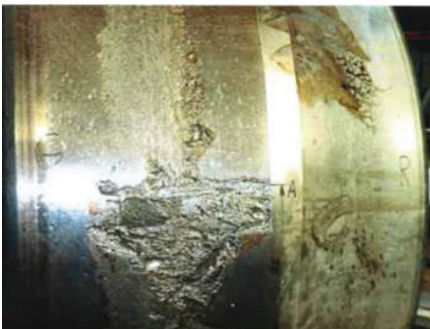
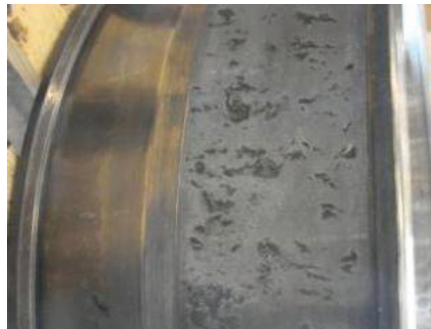
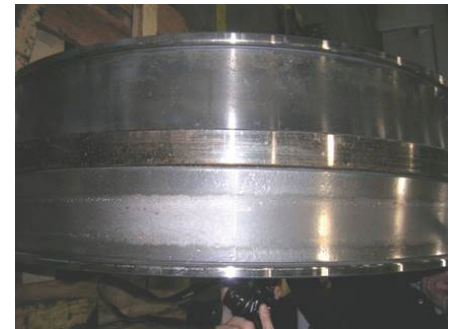
**Figure 3:** Common damage in SRB mainshaft

Field observations reveal that all three-point mount turbines are experiencing the same common damage modes, regardless of manufacturer. Although the damage takes longer to develop, many four-point mount arrangements are experiencing the same damage modes. These damage modes are the same and can include micropitting, edge loading, roller end thrust, single piece cage failures, cage and center guide ring wear, and debris damage. Images in Figure 3 below represent actual field damage from a variety of turbine models and MW classes. These unplanned main bearing replacements are costly and have significant impact on financial performance to the owner/operator.

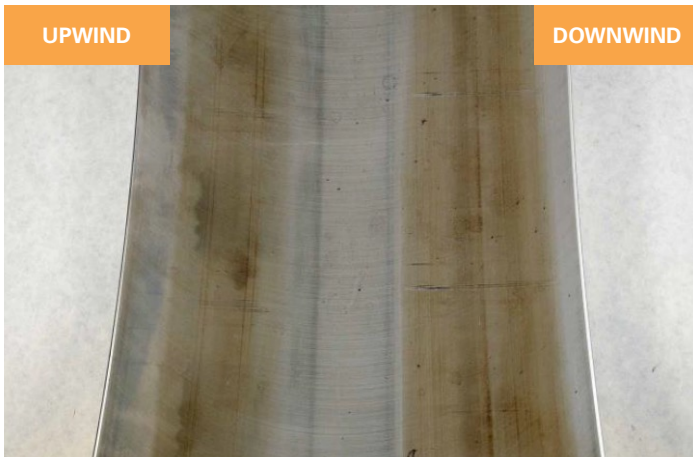
All bearing components appeared to exhibit limited adhesive wear with only a few debris dents on the downwind row. The insignificance of wear level on races is indicated by the presence of visible grind lines from the races' original finish grind. Figures 4-6 show a visual inspection of inner and outer races and an upwind and a downwind roller after the bearing was removed from service. Both roller complements appear to be in very good condition after operation showing what is light circumferential lining and the raceways have just light lubricant staining.

**Figure 4:** Outer race after seven years of service

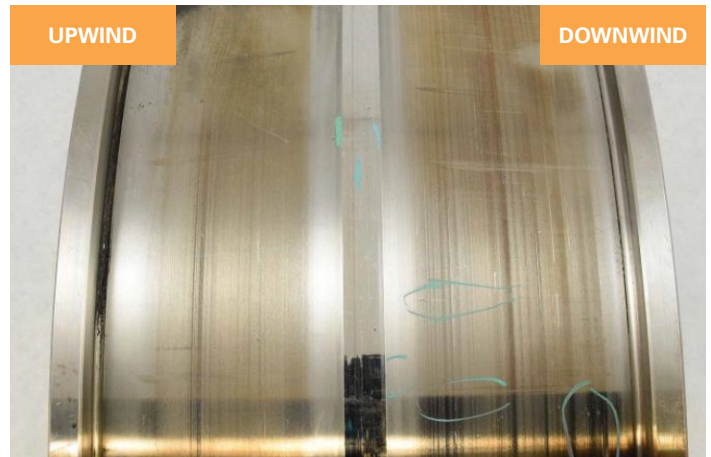
**Figure 5:** Inner race after seven years of service

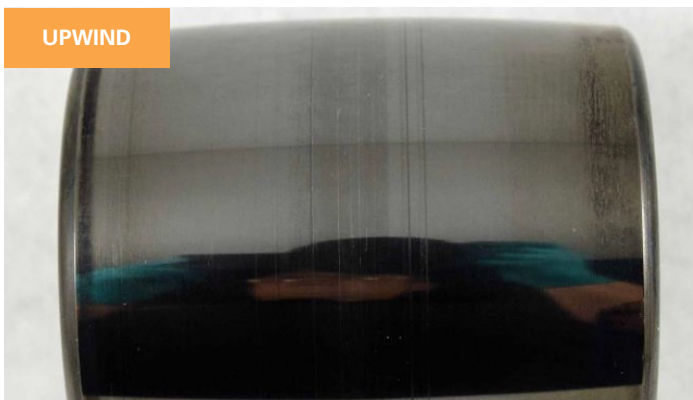
**Figure 6:** Upwind and downwind roller after seven years of service

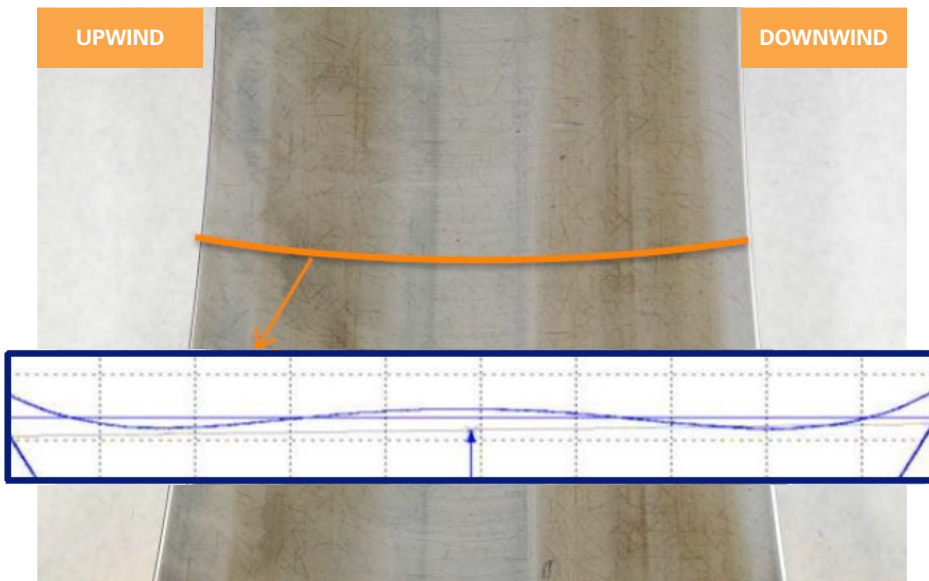
Outer ring profiles experienced some deviation from form. This could be caused by slight deformation rather than a representation of surface wear, visual appearance of raceway and presence of grind lines confirm this theory. Similarly, the Inner ring exhibited minimal signs of wear as well as minimal deviation from design intent. Much like the inner race, the roller profiles were in very good condition post-operation showing minimal signs of wear or deviation from intended profile.

**Figure 7:** Outer race profile trace

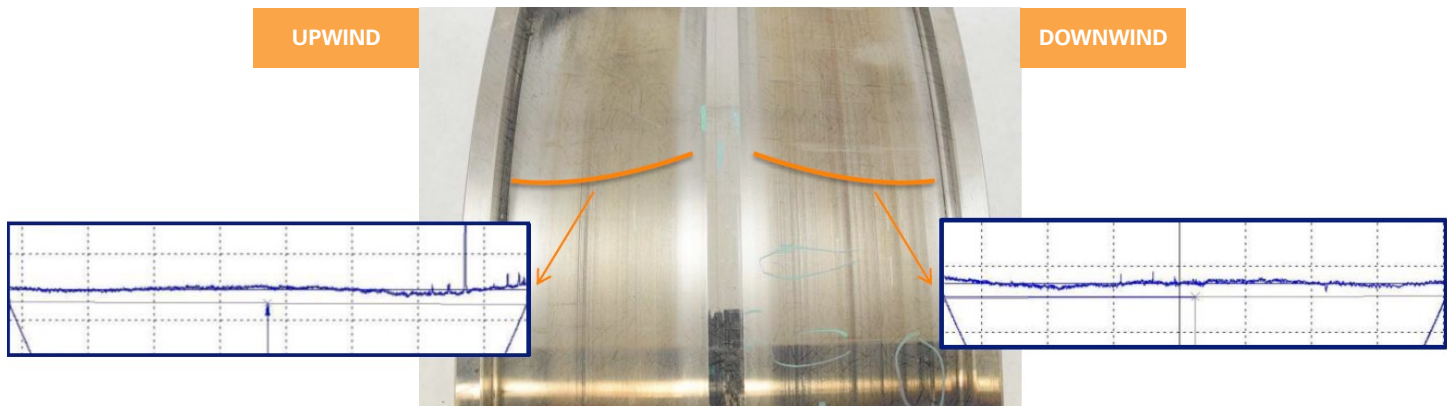
**Figure 8:** Inner race profile trace

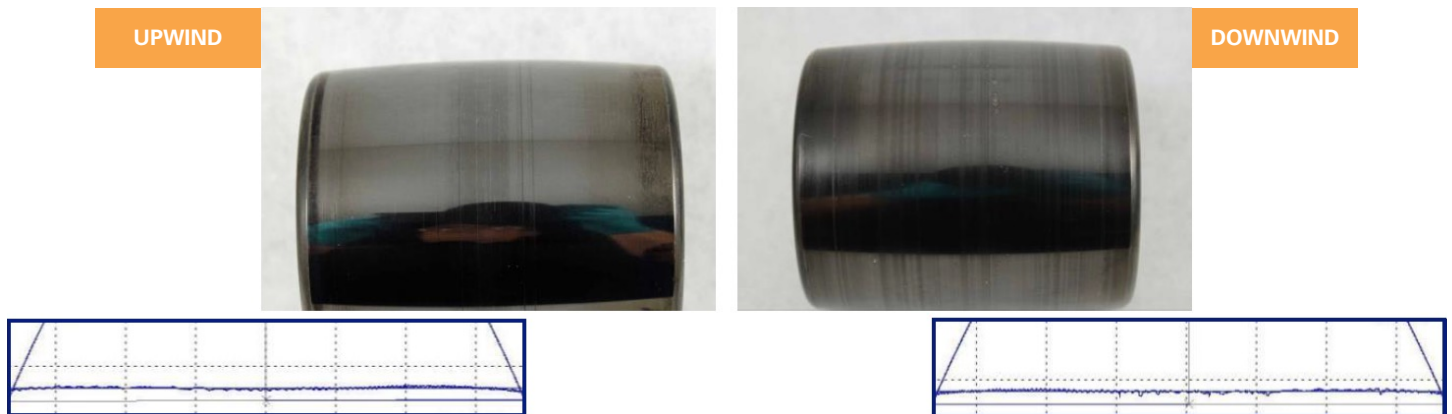
**Figure 9:** Upwind and downwind roller profile trace

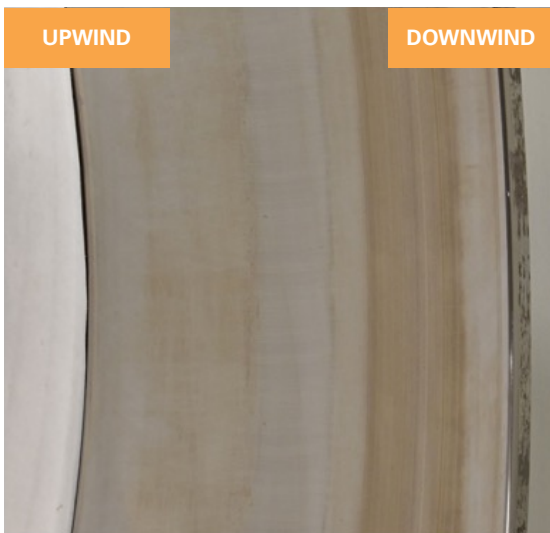
Much like the 7 Year DLC SRB, all bearing components showed limited adhesive wear with minimal damage on the downwind row. Crosshatch grind lines are still visible on the outer race. Both roller compliments also appear to be in good condition after operation, showing only light circumferential lining and minor denting.

Figure 13: Outer race after 10 years of service

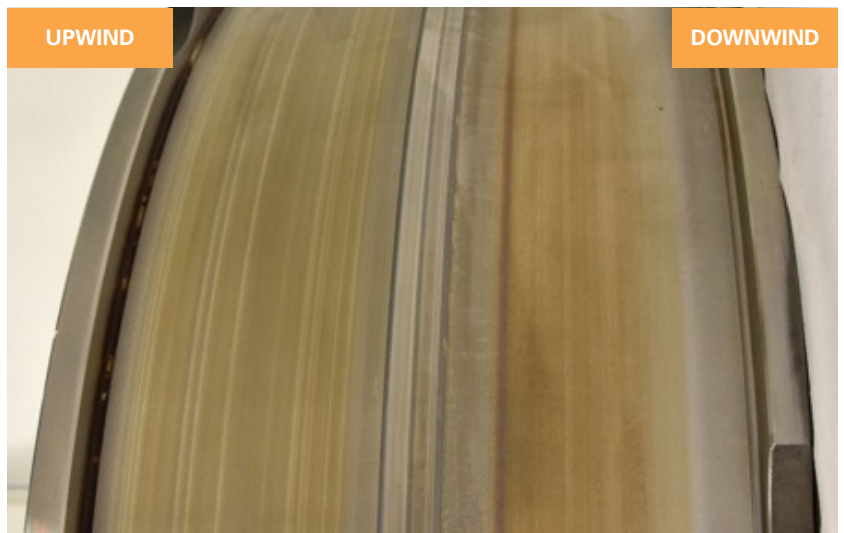
Figure 14: Inner race after 10 years of service

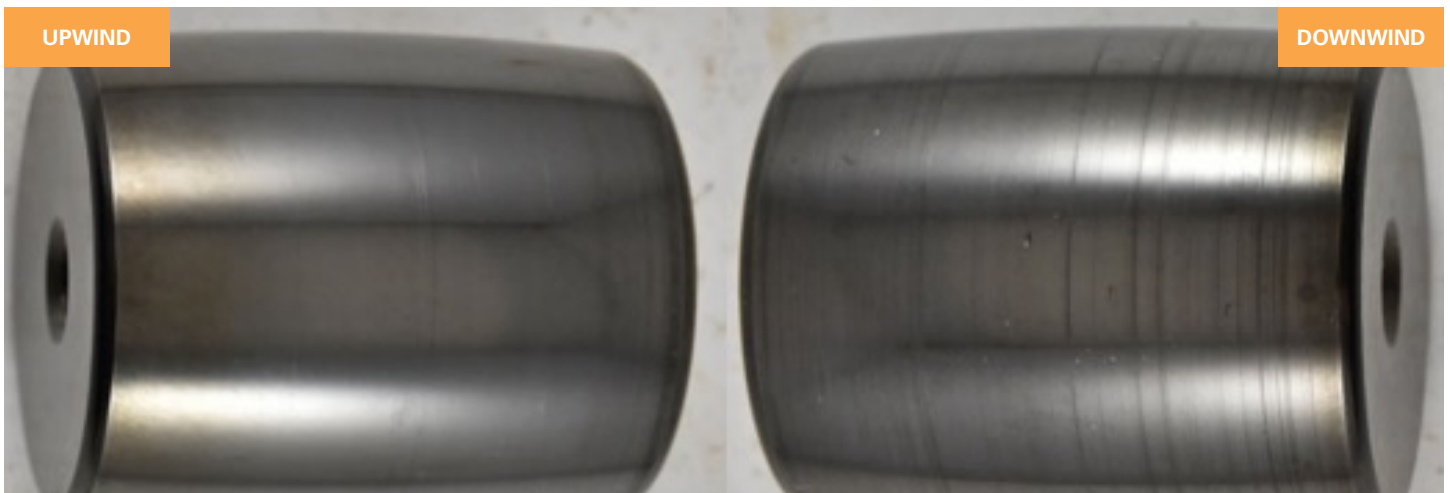
Figure 15: Upwind and downwind rollers after 10 years of service

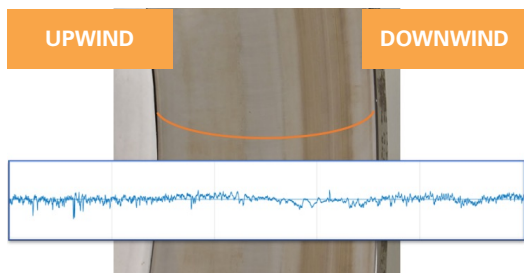
Following the visual inspection, a full metrology inspection was conducted on the bearing components. The inner and outer races showed light polishing with as-expected finishes in both the upwind and downwind rows. The still visible grind lines post-operation indicates little-to-no adhesive wear. The roller surface finishes are as expected with slightly increased roughness in the downwind row. This is a result of light circumferential lining as well as minor debris denting. Profile traces were also taken of each component. Each component showed little or no wear as shown by the levelized profile traces below.

**Figure 16:** Levelized outer race profile trace

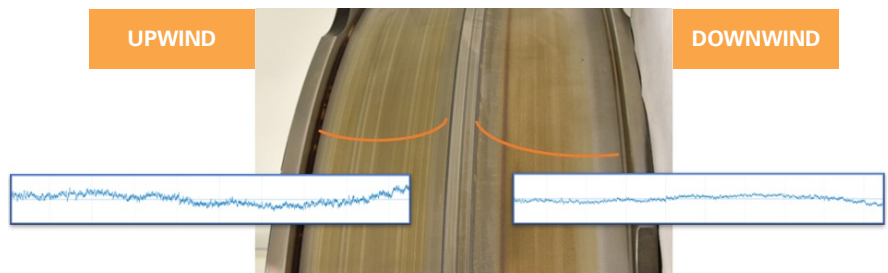
**Figure 17:** Levelized inner race profile trace

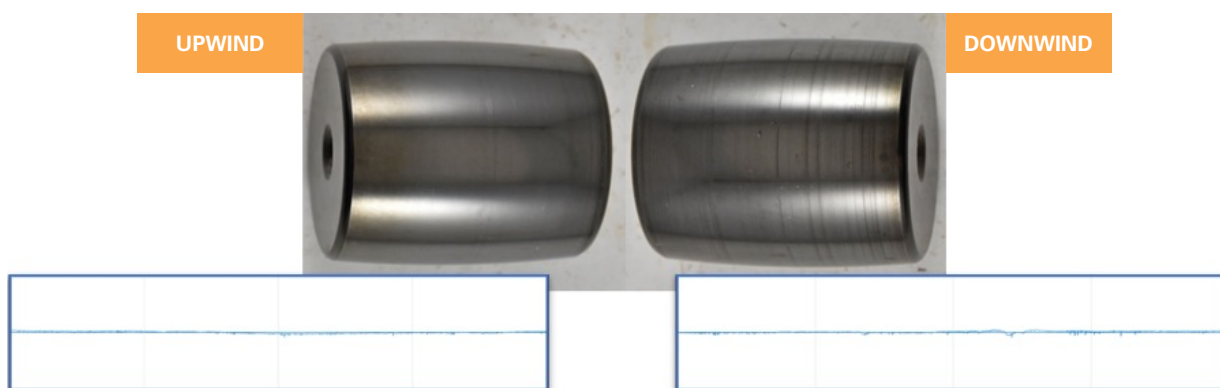
**Figure 18:** Levelized upwind and downwind roller profile traces
