Grease Weepage Visual Guidelines

TIMKEN
Where You Turn

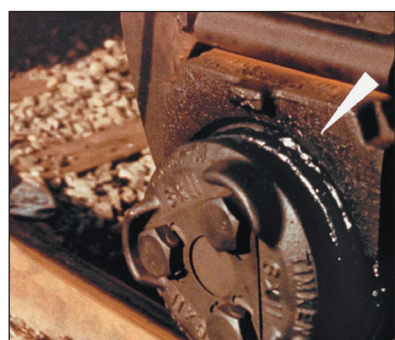
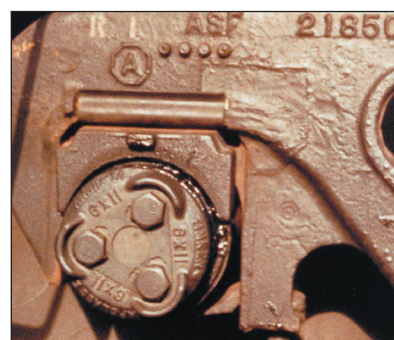
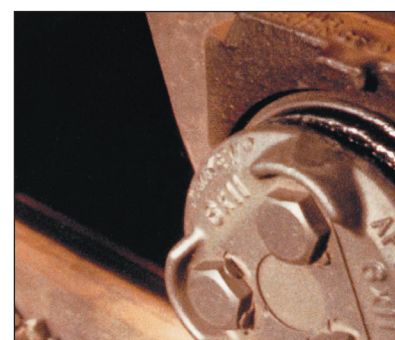
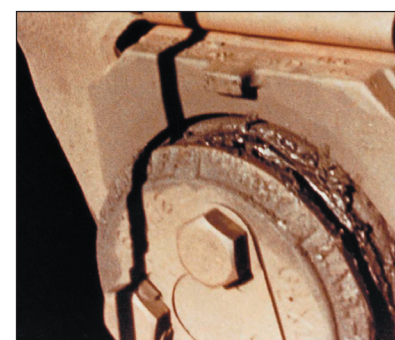
In previous years, the FRA conducted investigations of grease loss from roller bearings on double-stack container cars. Figures 1 to 4 show four examples of fresh grease weepage where the FRA inspectors noted the weepage and allowed the bearings to continue in service.

Figs. 1 to 4. Examples of fresh grease weepage where bearings were allowed to continue in service (note shiny/wet appearance of grease).

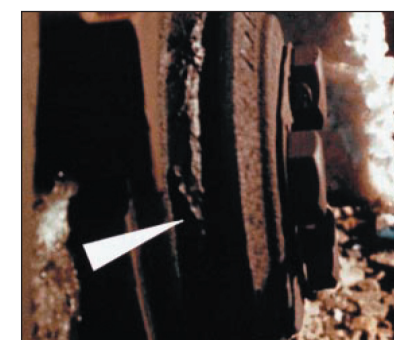
Fig. 5.

Figures 5 and 6 show examples of old grease accumulations (grease covered with road dirt) once weepage has slowed and/or subsided.

Fig. 5 (car) and Fig. 6 (locomotive) Examples of old grease accumulations (dried and covered with road dirt).
