Seal Damage Analysis and Troubleshooting

TROUBLESHOOTING GUIDE

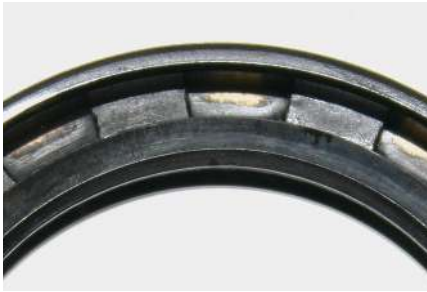
HARDENED SEALING LIP SURFACE

- Check the operating temperature. Excessive temperatures can cause the seal lip to harden.
- Check for inadequate lubrication or incompatibility with the sealed fluid.

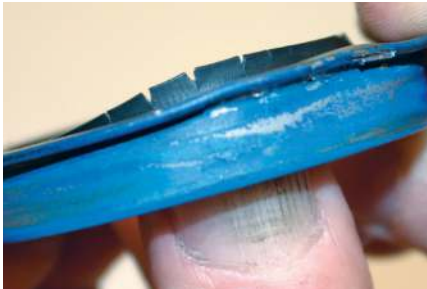
BRITTLE OR CRACKED SEALING LIP

- Check the operating temperature of the lubricant.
- Make sure the seal is properly sized. An overly tight fit on the shaft will cause overheating.
- Check the adequacy of the lubricant for the type of seal used.

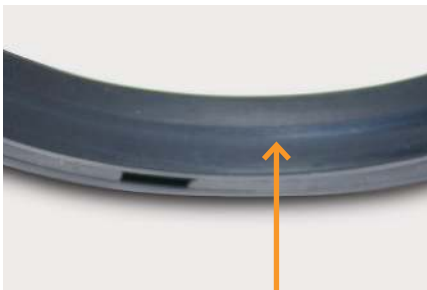
SEALING LIP SHOWS EXCESSIVE WEAR

- Make sure the shaft finish is not too rough at the point of lip contact.
- Make sure the seal was properly prelubricated before installation. Check the adequacy of the lubricant for the type of seal used.
- Make sure the seal is the proper fit. An overly tight fit can cause overheating and rapid wear.
- Make sure that shaft runout and misalignment do not exceed recommended limits.
- Make sure the seal sits close to the bearings. Check for excessive looseness in the bearing or splines.

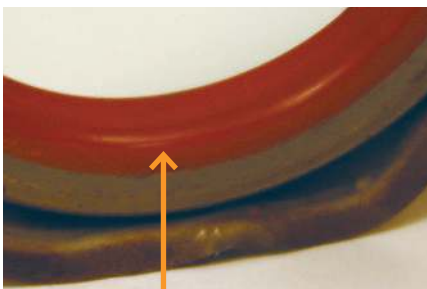
SEALING LIP WORN ON ONE SIDE (DIRECTIONAL HELIX MARKS WORN OFF)

- Make sure there is no misalignment of the shaft to the bore. This can generate rapid wear at a single point on the sealing lip.

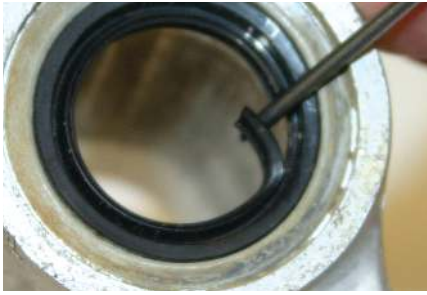
TORN SEAL LIP

- Damage may have been caused by improper assembly of related parts or the use of improper installation tools.
- Confirm that the seal was guarded by a seal protector when installed over splines, keyways or snap ring grooves.
- Make sure that proper installation tools and methods were used.
- Damage can result from debris contacting the seal lip during operating conditions, which may be too severe for the type of seal being used.

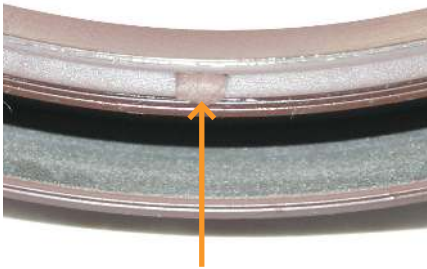
NICKED OR SCRATCHED SEALING LIP

- Damage may have been caused by careless storage and handling or use of improper assembly tools.
- Make sure the shaft was properly cleaned before installation.
- Make sure that proper installation tools and methods were used.
- Confirm that the seal was guarded by a seal protector when installed over splines, keyways or snap ring grooves.

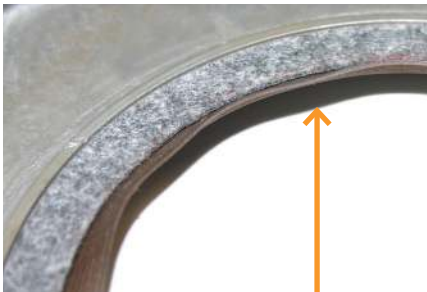
“BLOWN-OUT” SEALING LIP (OR REVERSED DIRECTION OF LIP CONTACT)

- Look for excessive pressure buildup or plugged vents. Vents may become clogged if they are not covered during painting.
- Check the lubricant level. Heating of the lubricant causes expansion resulting in pressure that can blow out the seal.

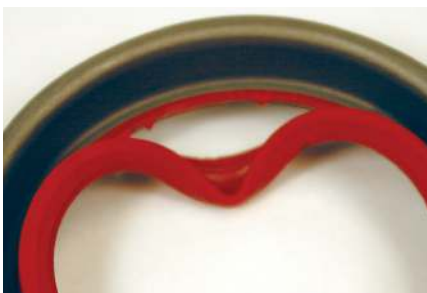
SOFTENED SEALING LIP SURFACE

- Check compatibility of the fluid and the sealing element. Cross contamination of incompatible fluids can cause a rubber seal to swell and disintegrate.

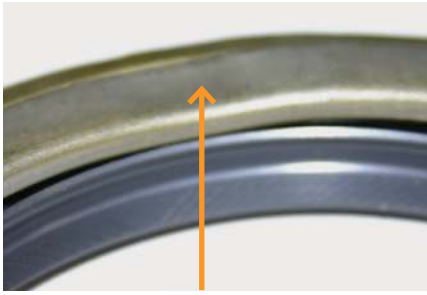
DISTORTED SEAL CASE

- Make sure the seal O.D. is not too large for the housing bore. The bore diameter should not vary from the recommended size of the seal that is used.
- Make sure the bore is not excessively out-of-round.
- Make sure that proper installation tools and methods were used.

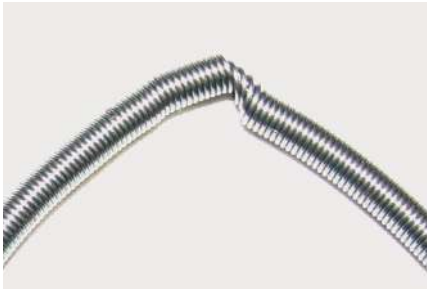
DAMAGED SEAL GARTER SPRING

- Make sure the proper installation tools and methods were used.
- Look for excessive spreading of the sealing lip during installation. It can damage the spring.

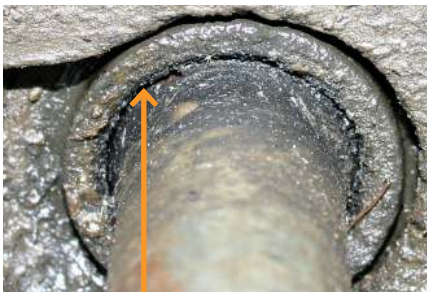
SEALING LIP CONTACT ON SHAFT IS TOO LIGHT

- Make sure the seal is the proper size.
- Make sure there is no excessive wear at the point of contact.
- Make sure the shaft is not too soft by reviewing the minimum hardness specifications for existing operation conditions.
- Confirm that proper installation tools were used. If the mounting cones and sleeves have an O.D. of more than 1/32" greater than the shaft, the sealing lip may be overstretched.

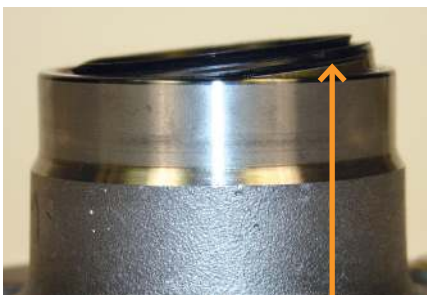
SEAL COCKED IN THE HOUSING

- Make sure that proper installation tools and methods were used.
- Make sure that the seal O.D. is not too large for the bore.
- Check the bore for burrs, scales or chips that may prevent proper sealing.

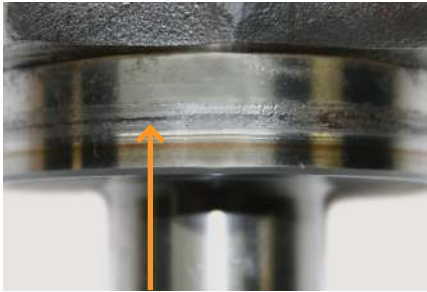
EXCESSIVE SHAFT WEAR (OFTEN CAUSED BY ABRASIVE DIRT OR GRIT)

- Check exterior dust conditions, which may be too severe for the type of seal being used.
- Ensure that sufficient lubrication is used and that there are no coarse contaminants in the grease.
- Verify shaft hardness limits. The shaft may be too soft.
- Make sure the seal is the proper size.

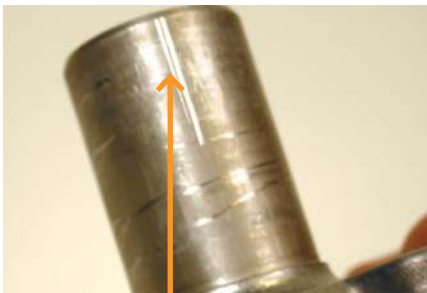
SCRATCHED OR GOUGED SHAFT

- Properly clean the shaft before installing the seal. Shafts must be thoroughly cleaned and free from paint, shellac or cement. Debris where the lip contacts the shaft can prevent proper sealing.

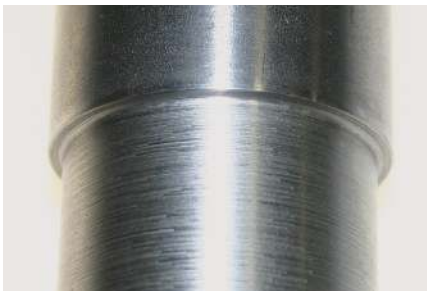
SPIRAL MACHINE GROOVES ON SHAFT

- Take note of spiral grooves on the shaft, as they may result in lubricant leakage.

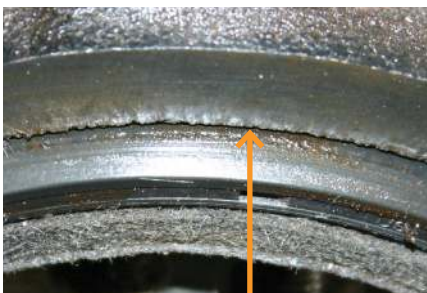
LEAKAGE AROUND SEAL O.D.

- Check bore surface finish and size. If the bore is only slightly out-of-round (0.001"), use special cement on the O.D. seal surface to offset this condition.
- Check the seal for signs of damage to the O.D. Look for dings, large and deep scrapes or a skewed O.D. These may indicate improper handling.
- Check the bore for scrapes, pits and other physical damage.

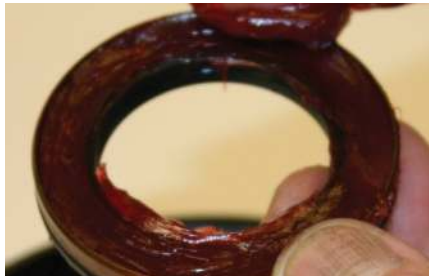
EXCESSIVE PRELUBRICATION

- Excessive prelubrication is not leakage. When too much prelubricant is used, the excess melts and runs out. Verify this possibility before removing a seal that appears to be leaking.

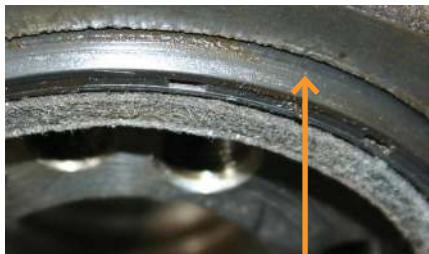
SEAL FALLING OUT OF THE BORE

- Check the sizes of the bore and the seal. The bore may be too big or the seal may be too small.

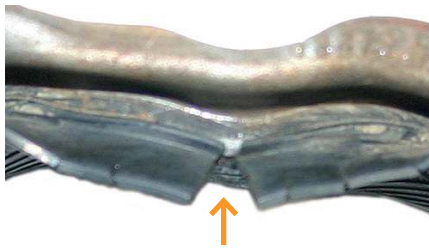
DRY RUNNING

- Check the location of the bearing and any flanges that may keep lubrication away from the seal.
