Technical Article

Improving Bearing Life in Wind Turbine Mainshafts and Gearboxes

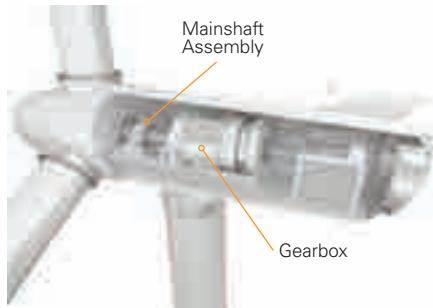
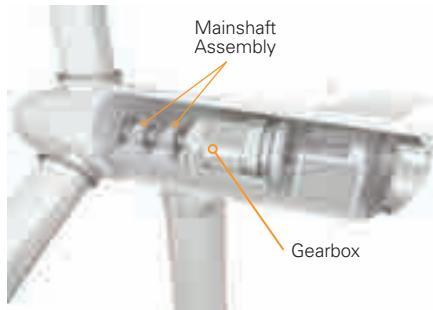
Figure 1:

Three-Point Mount Mainshaft Arrangement

Four-Point Mount Mainshaft Arrangement

As measured by total MW, modular wind turbine designs dominate the industry and commonly use SRBs to support and carry the mainshaft loads. Classified as three- and four-point designs, Figure 1 illustrates the nomenclature.

The three-point mount in the left-hand illustration has a single support of the dynamic loading with a single two-row SRB in front of the gearbox. There are two additional support points located at the gearbox torque arms, which yields three support points. Advantages of the three-point mount arrangement utilizing SRBs include:

Similarly, the four-point mount uses two gearbox torque arms to help support the mainshaft with two 2-row SRBs for the mainshaft support, which yields four support points. Normally the UW floating SRB carries predominantly radial loads while the DW fixed SRB carries the majority of the wind thrust loading. This is an improvement over the three-point mount design, but there is increasing field evidence of premature damage to the DW fixed SRB location similar to that of the three-point mount design.

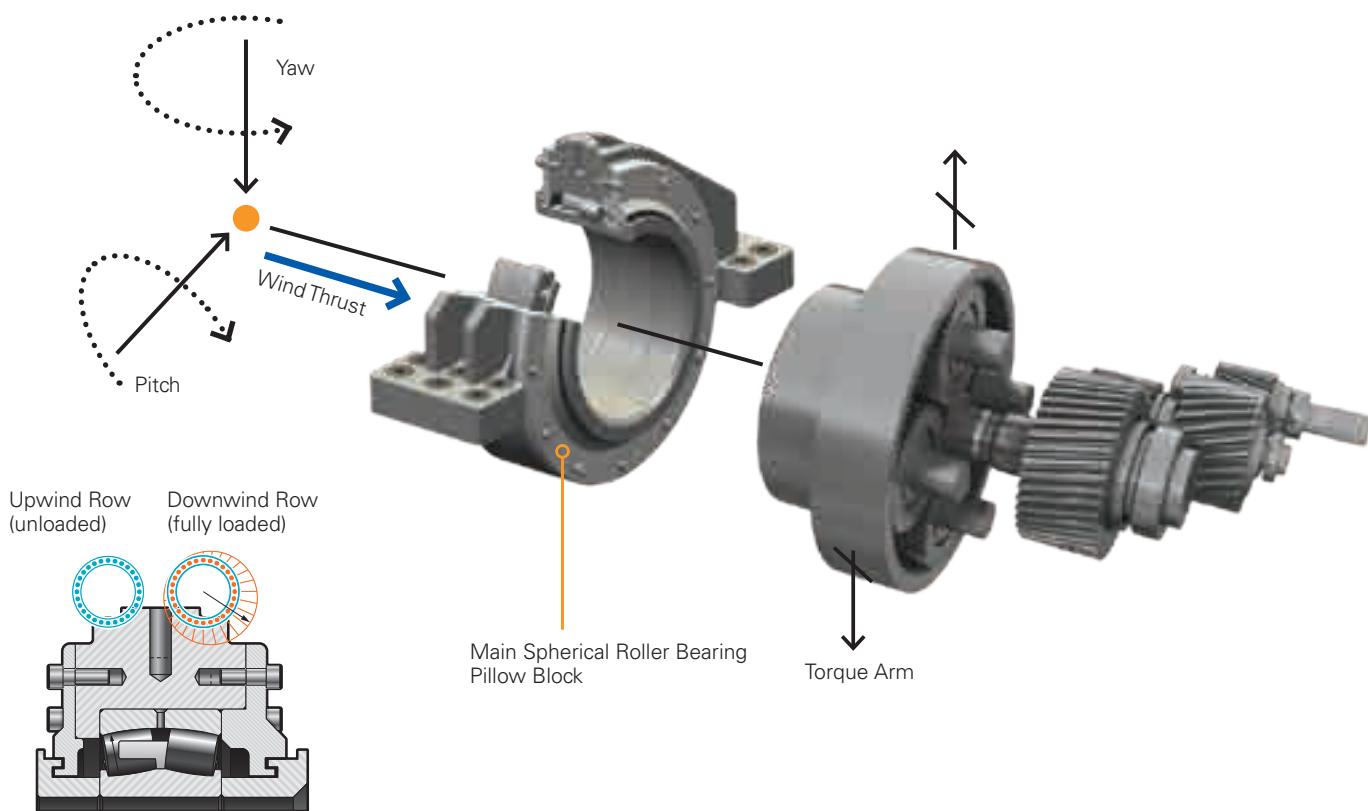
Thrust loading in the application is many times greater than this limit. With these high axial loads, only the DW row supports both the radial and thrust loading; the UW row is completely unloaded. This is a significant contributor to the micropitting damage and results in a less-than-ideal operating condition. Figure 2 depicts the unequal load sharing.

Figure 2: Applied Loads and Unequal Load Sharing

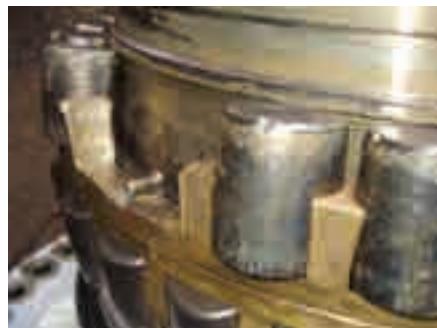
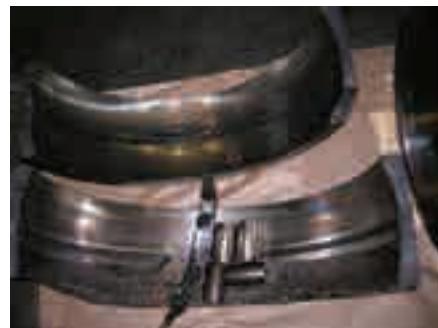
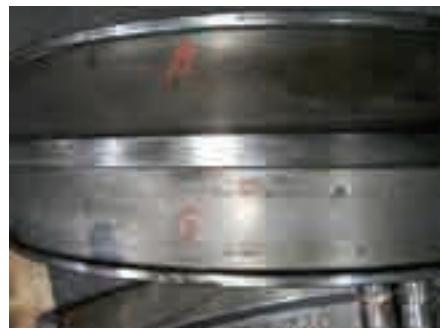
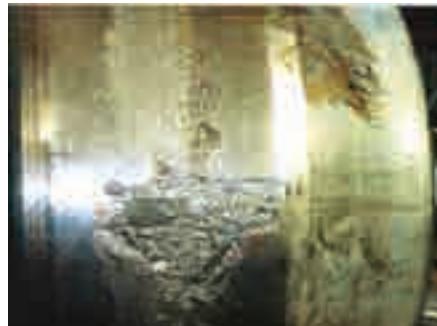
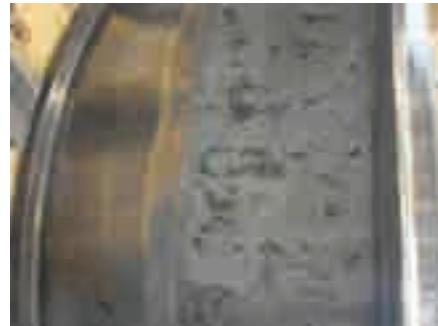
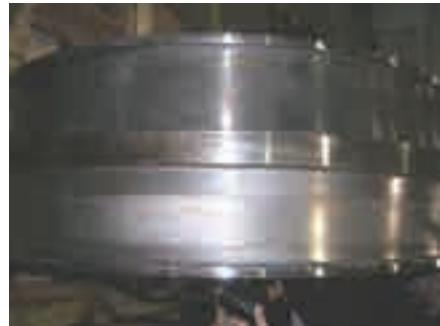
Figure 3: Common Damage in SRB Mainshaft

Field observations reveal that all three-point mount turbines experience the same common damage modes, regardless of manufacturer. Although the damage takes longer to develop, many four-point mount arrangements are experiencing the same damage modes. These damage modes are identical and can include micropitting, edge loading, roller end thrust, single piece cage failures, cage and center guide ring wear, and debris damage. The images in Figure 3 below represent actual field damage from a variety of turbine models and MW-class turbines. These unplanned main bearing replacements are costly and have a significant impact on financial performance for the owner/operator.

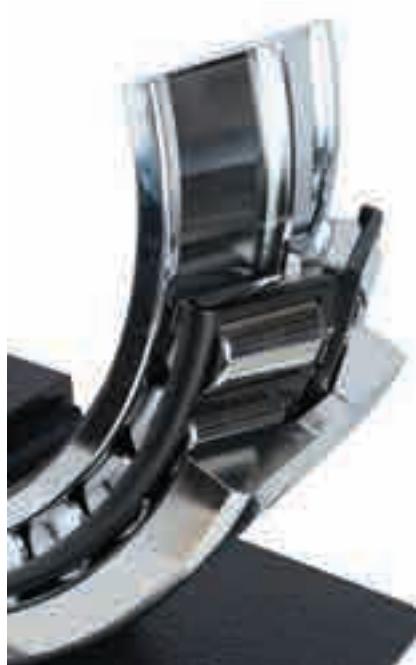
The TDI bearing has a number of advantages. When following careful assembly and maintenance procedures, the bearing can yield significantly improved system performance. The benefits include:

- Drop-in replacement for SRB
- Preloaded system results in low risk of sliding, skidding, and smearing
- Improved system stiffness
- Eliminates axial mainshaft thrusting into the gearbox

The benefits of a TDI bearing include reduced bearing wear, reduced deflection/load into the gearbox, and increased system rigidity. ATDI mainshaft design can optimize the overall powertrain system due to its design and preload characteristics. The design characteristics help ensure excellent system stability/rigidity, load sharing between rows, and predictable roller-to-race interactions. In SRB replacements, a single preloaded TDI can manage the combination of radial and thrust loads much better than the SRB. The increased bearing stiffness and improved load sharing also help to minimize fretting damage between the bearing inner ring and the shaft.

Analysis shows that a preloaded bearing system significantly improves load share between rows, reduces false brinelling, and reduces loads and deflections transmitted to the gearbox. The improved load share improves overall system dynamics and performance. The optimized preloaded system helps ensure excellent system stability in even the heaviest of wind conditions. The specially designed internal geometry controls roller-to-raceway stress profiles and handles the initial system misalignment inherent in these turbine configurations. In uptower field-testing, TDI mainshaft bearings used in a 1.5 MW three-point mount configuration continue to operate exceptionally well and validate the predictions.

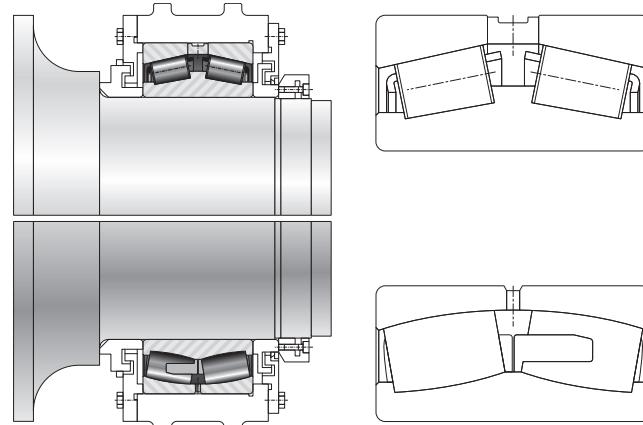
The TDI is an excellent choice to ensure load sharing across both bearing rows, while being more flexible for system misalignment than a tapered double outer (TDO) design. Having higher load capacity, the bearing preload helps mitigate smearing/skidding and micropitting. Designed as a direct drop-in, the TDI uses the existing OE pillow block housing and shaft without changing shaft and housing fits. Represented in Figure 4 below is a comparison of the TDI to the SRB in an identical housing.

- Limits misalignment through preload
- Accommodates some misalignment through internal geometry and roller profiles
- Limits thrust to gearbox
- Accommodates some misalignment through clearance and shape
- Transmits thrust to gearbox

Figure 4: TDI Mainshaft Bearing Arrangement

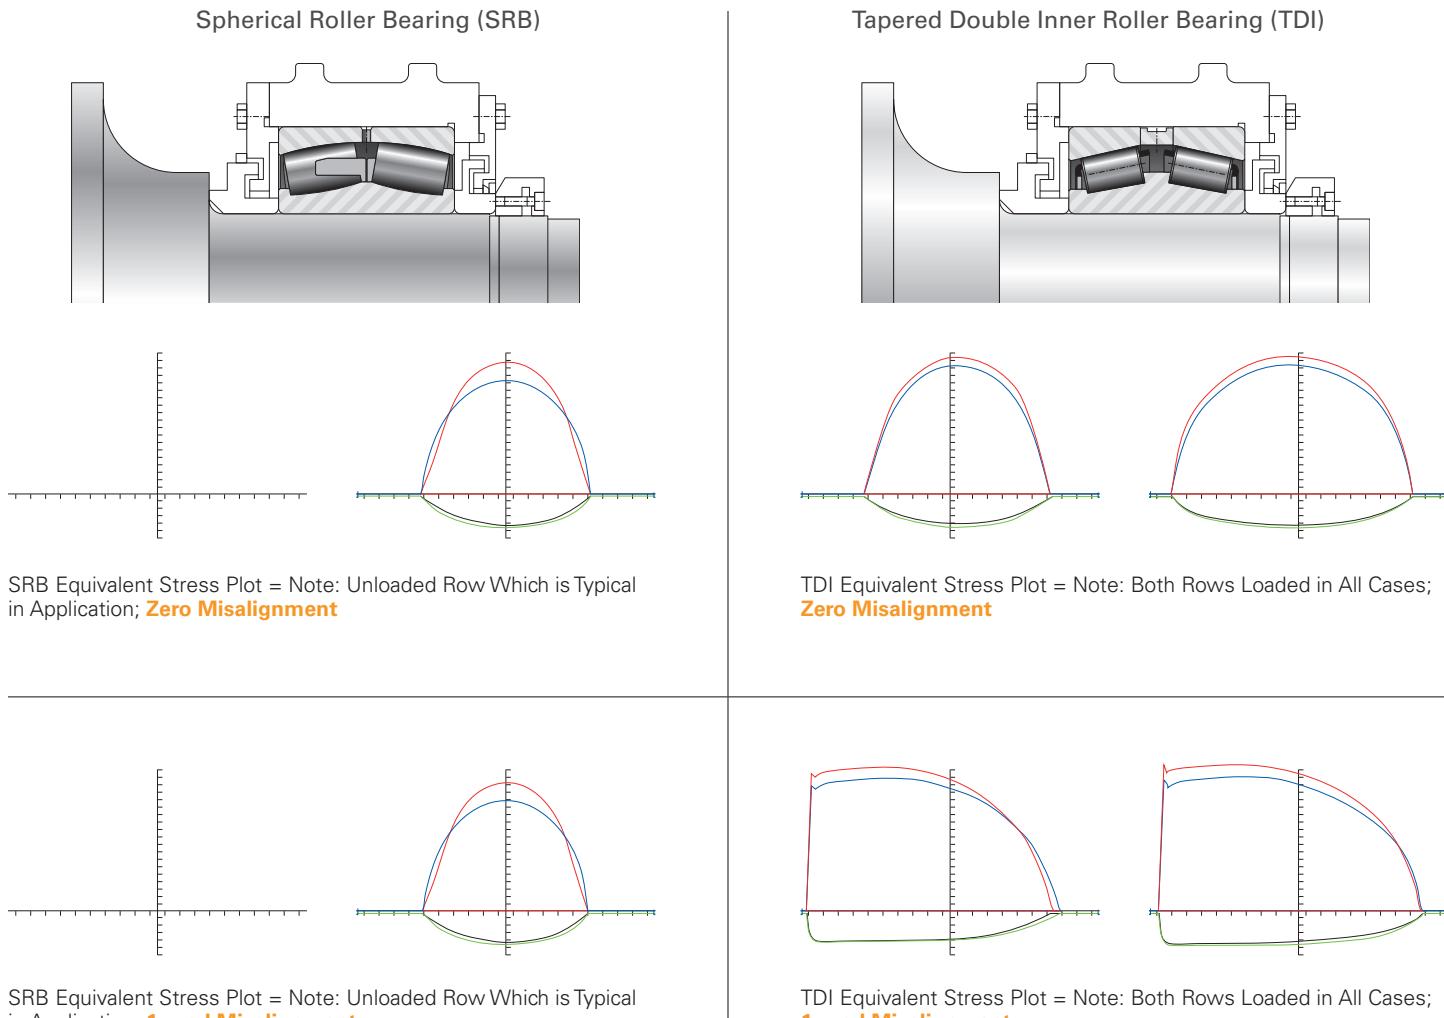
Bearing design criteria include a 20-year or more fatigue life prediction, dynamic stress limits of 1650 MPa, extreme stress limits of 4000 MPa, and the capability of handling a high degree of static and operating misalignment. Timken's proprietary and advanced modeling tool, Syber, considers overall system stiffness and initial imposed bearing misalignment, as well as dynamic misalignment for bearing development. To properly model the support arms, the gearbox connection included specific stiffness information for the axial, radial, and tilting stiffness. Figures 5 and 6 demonstrate the comparison of load zone and load sharing when converting from an SRB to a TDI design.

Figure 5: Equivalent Load Cases
Load Zone Calculations for the 240/600 SRB and NP822933-90WA1 TDI:

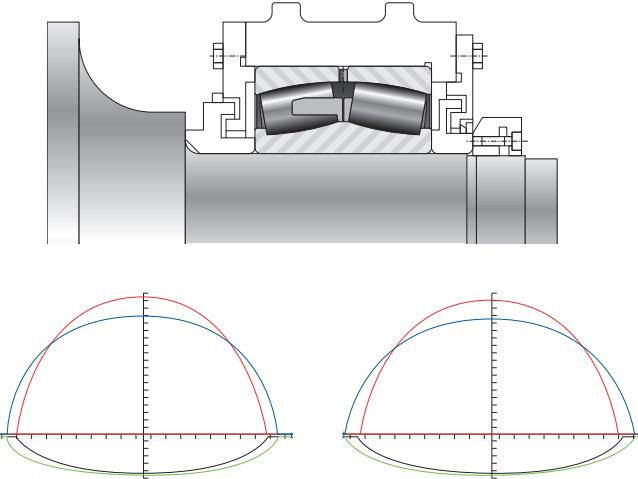
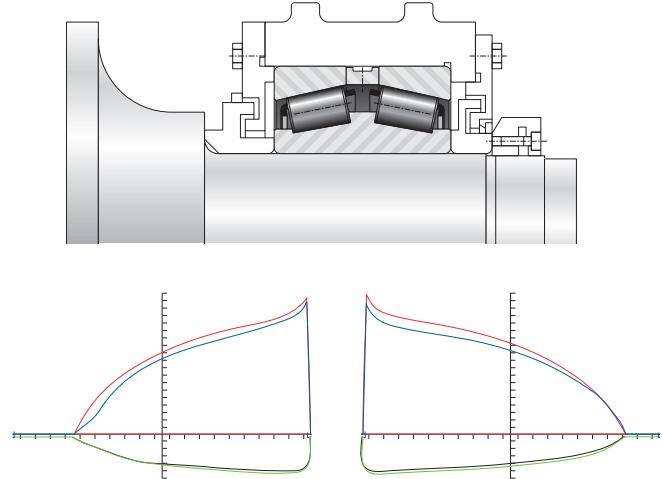
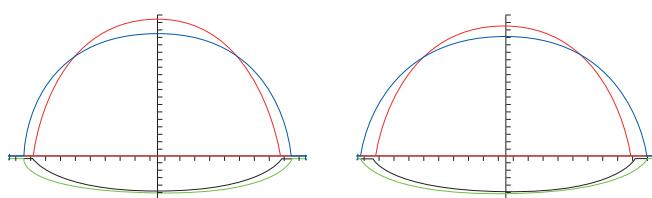
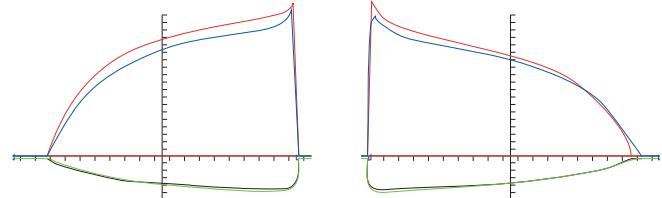
Figure 6: Extreme Load Cases
Load Zone Calculations for the 240/600 SRB and NP822933-90WA1 TDI:

The bearing could easily become misaligned in mounting due to the system tolerances stack-up or the coaxial relationship between the shaft centerline at the bearing position and the gearbox connection centerline with the mainshaft. Optimized internal geometry, combined with proper uptower assembly procedures, mitigates the assembly concerns. Analysis included the angular system displacement as well as the induced misalignment under fatigue and extreme loading to determine the impact on bearing and system performance.

SRB Extreme Stress Plot; **Zero Misalignment**

TDI Extreme Stress Plot; **Zero Misalignment**

SRB Extreme Stress Plot; **1mrad Misalignment**

TDI Extreme Stress Plot; **1mrad Misalignment**

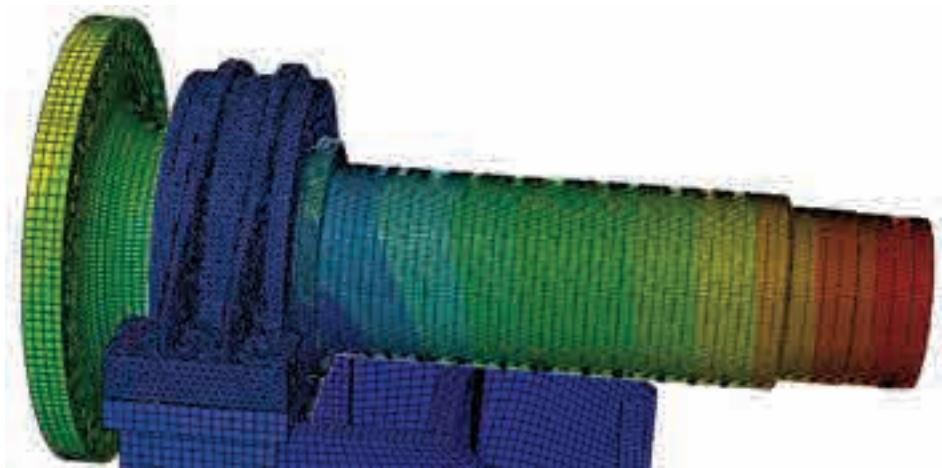
Modeling techniques relate to defining linear elastic material properties in the solid models of the shaft and pillow block and defining the bolts as ABAQUS pre-tension beam elements. Figures 7 and 8 depict the overall system modeling.

Figure 7: FE Model Set-Up

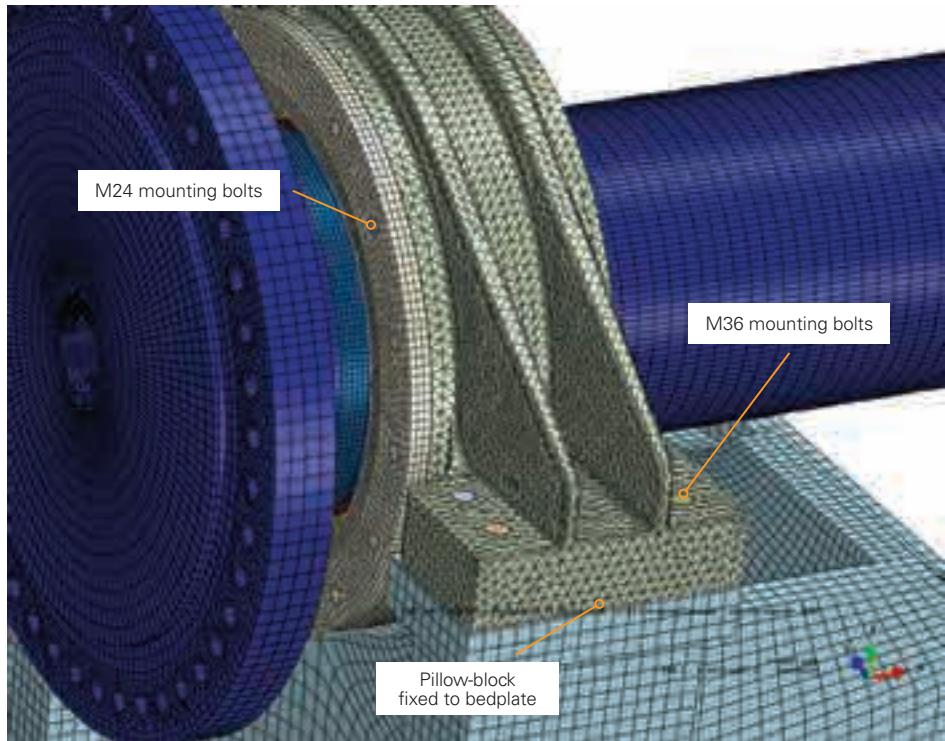
Figure 8: FE Model Bolted Connections

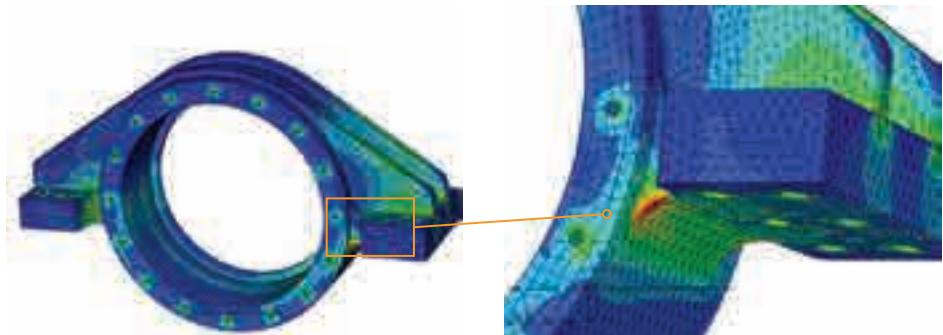
Analyzing both the SRB and TDI housed unit, the maximum stress in the pillow block occurs in the lower radius of the support. The highest stress location in the shaft is located at the UW shoulder fillet radius. The bedplate support exhibits the highest stress at the interface of the pillow block and the bedplate.

Figures 9 and 10 highlight the maximum stress location with Table 2 (next page), summarizing the results for both equivalent and extreme load cases. Table 3 (next page) summarizes the bolt stress analysis.

Figure 9: Pillow Block Maximum Stress Location

The stress levels and safety factors indicate very similar performance between the SRB and TDI. Finite element analysis (FEA) predicted minimal changes to the stress levels in all components when comparing the results of the TDI to the SRB. This shows that converting from one bearing type to the other imparts negligible effects on the system.

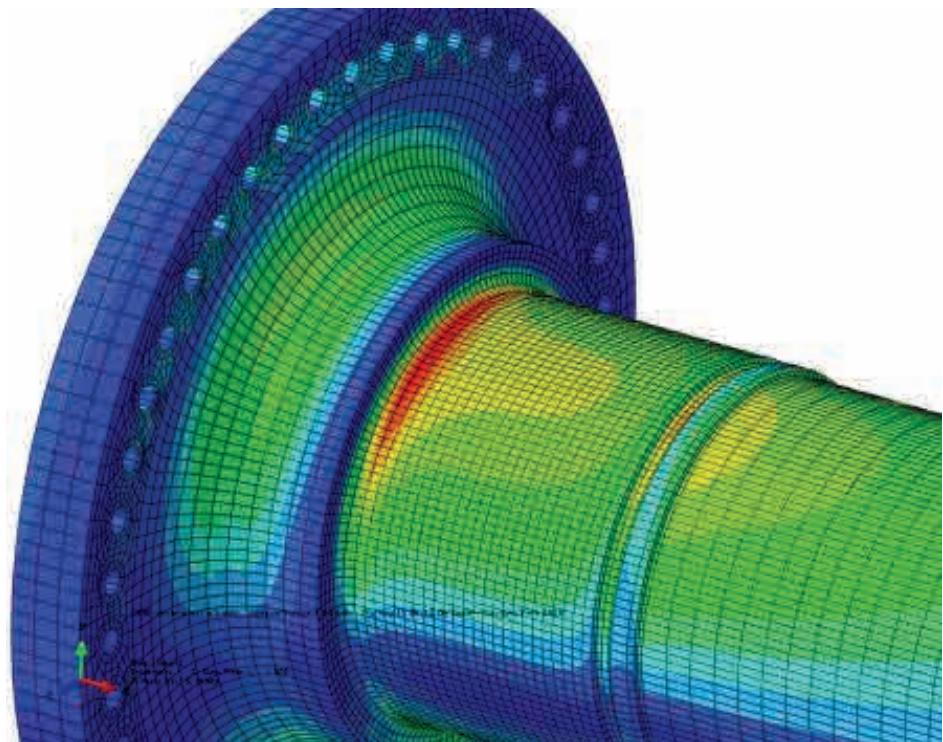
Figure 10: Shaft Maximum Stress Location

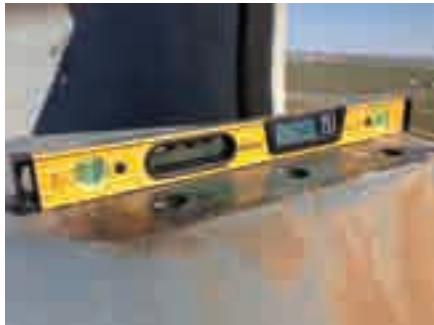
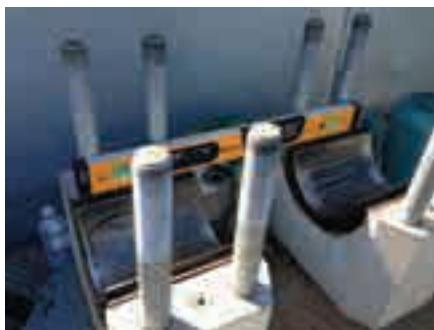
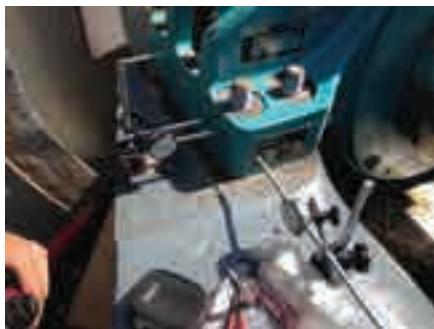
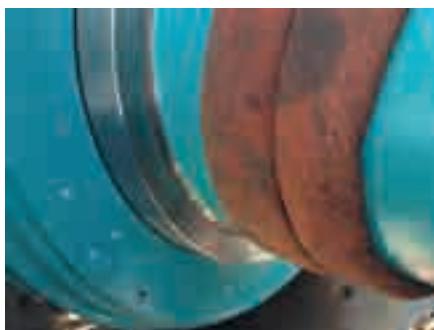
Figure 13: Bed Plate Pillow Block Interface

Figure 14: Torque Arm Alignment Measurement

Figure 15: MS Assembly Movement Check

Figure 16: MS Assembly Measurement

This is possible by turning the gearbox output-shaft brake rotor/locking gear. Once rotation is complete and the housing assembly is “centered,” final assembly of the mainshaft mounting bolts occurs per the turbine manufacturer’s torque specifications. The procedure for mounting and aligning the mainshaft assembly uptower is depicted in Figures 13-16.

The uptower assembly occurred with the continued assistance of Timken service engineering and followed the procedures developed in conjunction with the customer. One key aspect is to ensure the main bearing assembly is properly oriented to the gearbox prior to the final installation of the housing to the bedplate. Rotating the mainshaft 360° in each direction after installing the assembly, but before installing the gearbox mount caps or tightening the bearing housing bolts, allows the housing assembly to orient itself with respect to the gearbox connection.

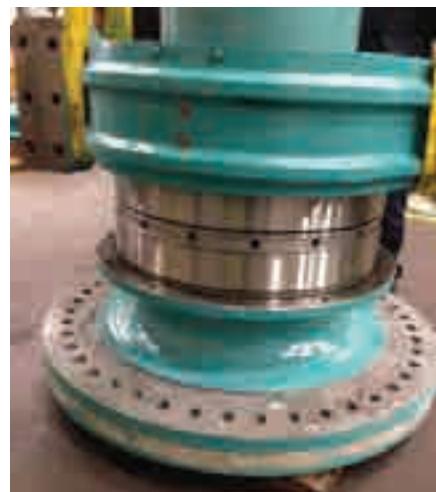
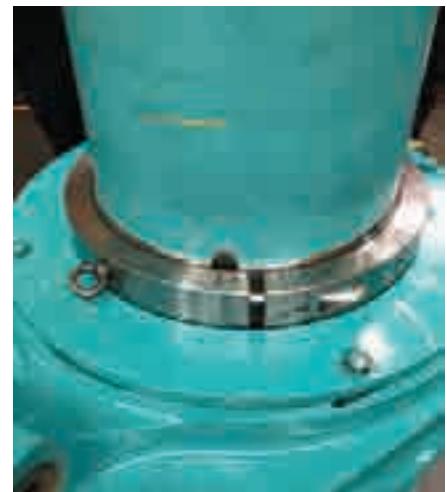
Figure 11: Pillow Block Install over TDI

Figure 12: Completed Assembly

Figures 11 and 12 show a successfully installed bearing.

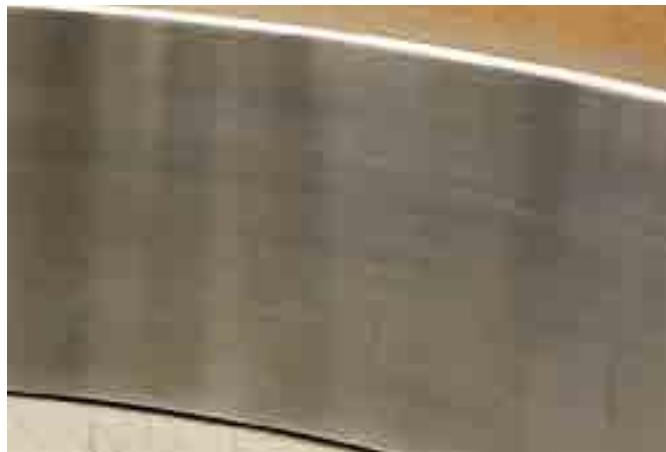
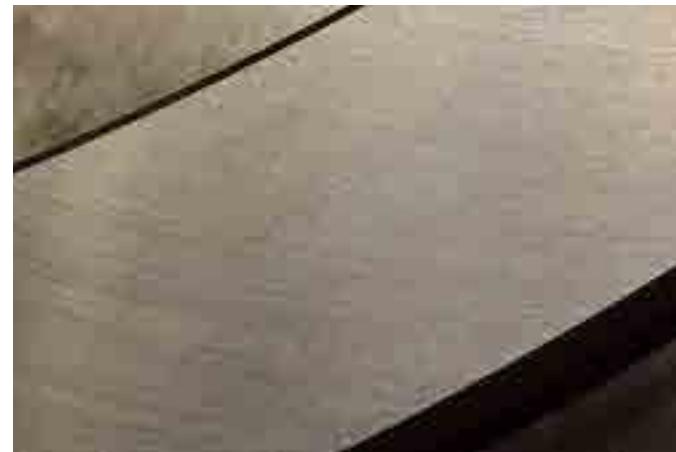
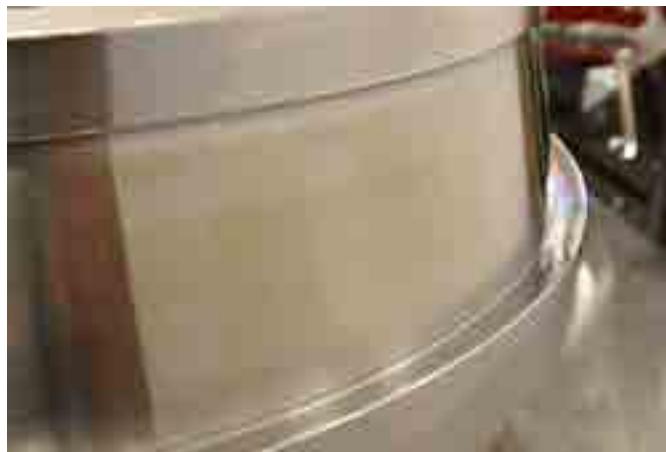
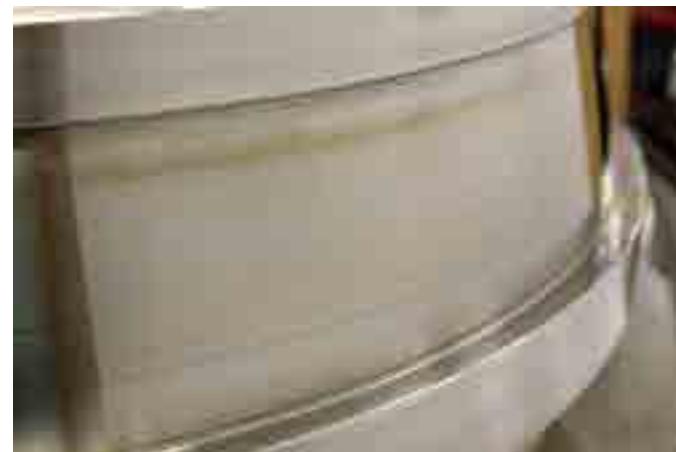
The inspection pictures shown in Figures 17 through 20 represent the condition of the rollers and race after two years of runtime. With no early indications of damage relating to peeling, micropitting, etc., the images show the excellent running condition of the TDI bearing.

Figure 17: Bearing Cup Raceway

Figure 18: Bearing Cup

Figure 19: Bearing Cone Raceway

Figure 20: Bearing Cone Raceway

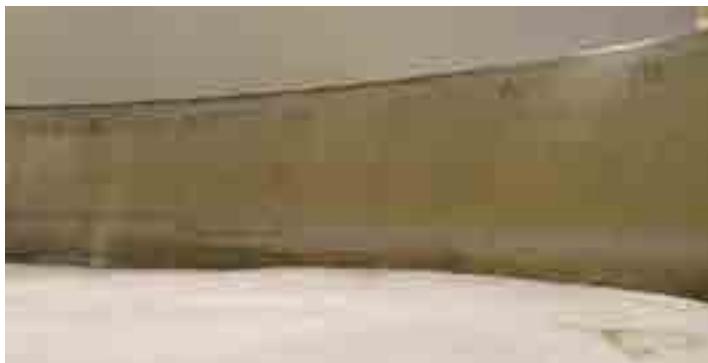
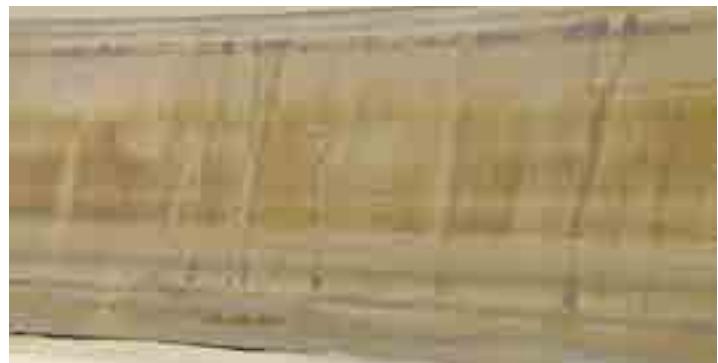
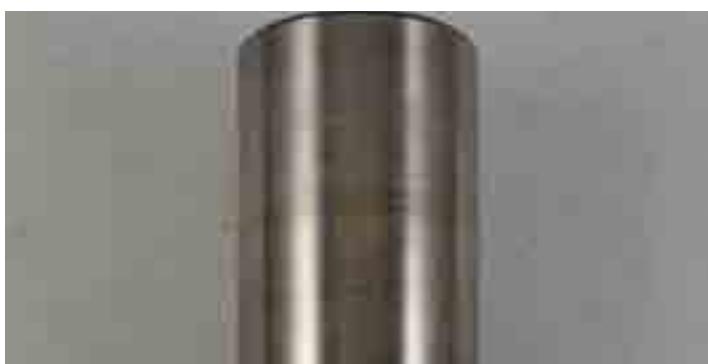
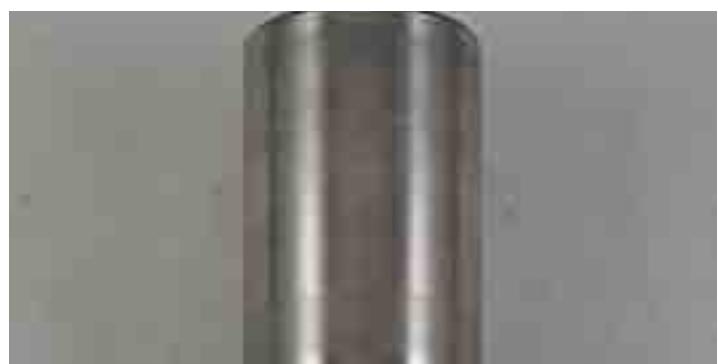
The inspection pictures shown in Figures 21 through 26 represent the condition of the rollers and cup and cone races after five years of runtime. The discoloration seen on the bearing races is caused by grease staining during operation as well as corrosion due to water ingress after teardown. This discoloration is purely superficial and does not suggest any performance issues of the bearing in operation. Similar to the TDI with two years of runtime, there is no indication of surface-initiated damage such as micropitting or peeling, and the bearing races appear to be in like-new condition outside of some superficial lube staining and corrosion damage caused by water damage after operation.

Figure 21: Upwind Cup Raceway

Figure 22: Downwind Cup Raceway

Figure 23: Upwind Cone Raceway

Figure 24: Downwind Cone Raceway

Figure 25: Upwind Roller

Figure 26: Downwind Roller

Through field trials, the mainshaft TDI has proven both its reliability as well as its performance. The two bearings removed from service gave no visual indication of wear or the other surface-initiated damage modes that are typically seen in current designs. In addition to visual inspection, profile traces of the bearing rings proved that profile geometry was still within specification after five years of service. Grease evaluations taken after various periods of service suggest excellent bearing performance throughout the life of the turbine.

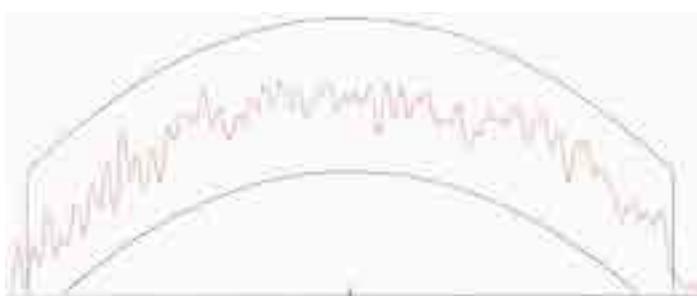
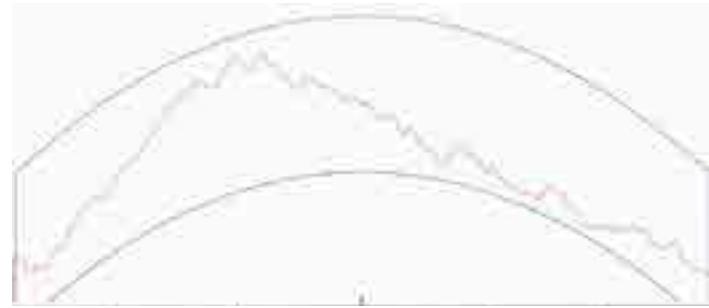
In addition to visual inspection, traces of the race profile were completed to further inspect the condition of the components. Figures 27 and 28 show the results of this inspection on the cup and cone races. The red trace shows the actual race profile, and the blue envelope shows the tolerance band that is targeted when the cup and cone are manufactured. The image below proves that even after five years of service, the race profile still meets the specified geometry for a brand-new cup race.

Figure 27: Cup Profile Trace with Tolerance Band

Figure 28: Cone Profile Trace with Tolerance Band

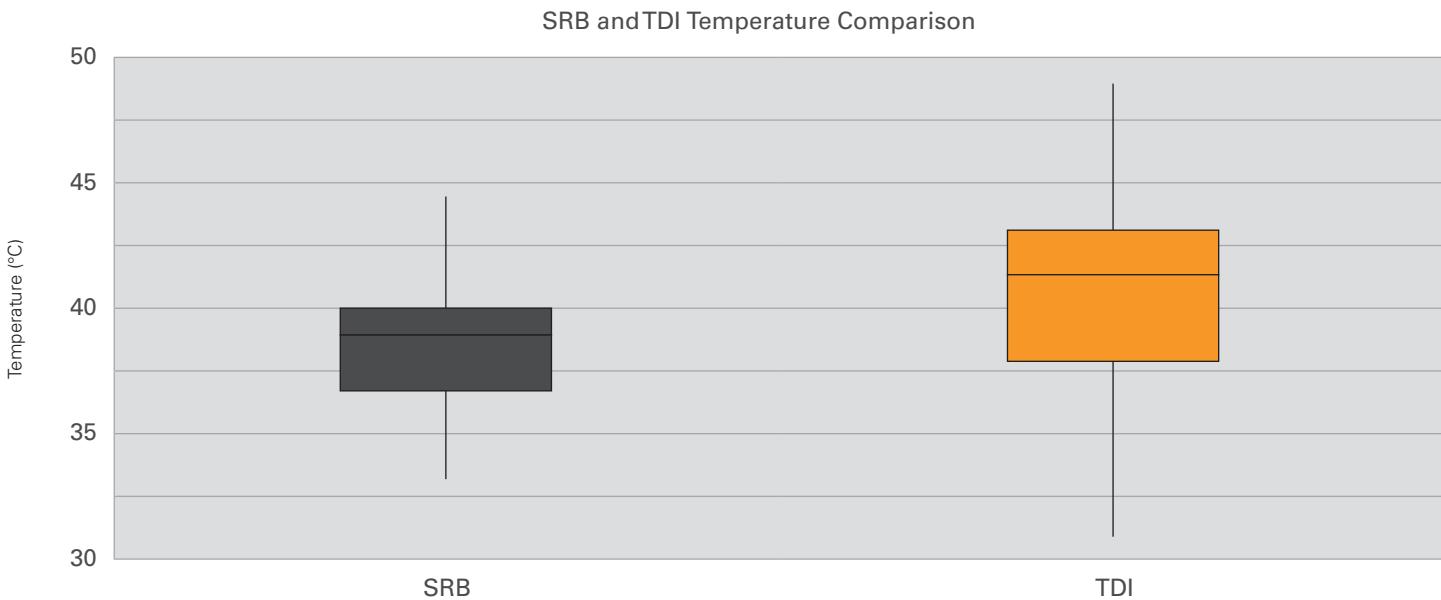
The operating temperature of TDI bearings is comparable to an OE SRB, as shown in Figure 29 where the SRB data originates from a neighboring turbine and offers the best comparison point within the wind farm. Depending on ambient condition and nacelle temperature conditions, temperature readings for the TDI ranged from 38° to 46°C, as compared to 36° to 40°C for an OE SRB.

As expected, the preloaded TDI is operating slightly warmer. The difference is attributed to the bearing preload, as well as the previously discussed temperature sensor location being more in the center of the load zone while the OE SRB temperature sensor is closer to the 1:00 position of the housing.

Figure 29: Main Bearing Temperature

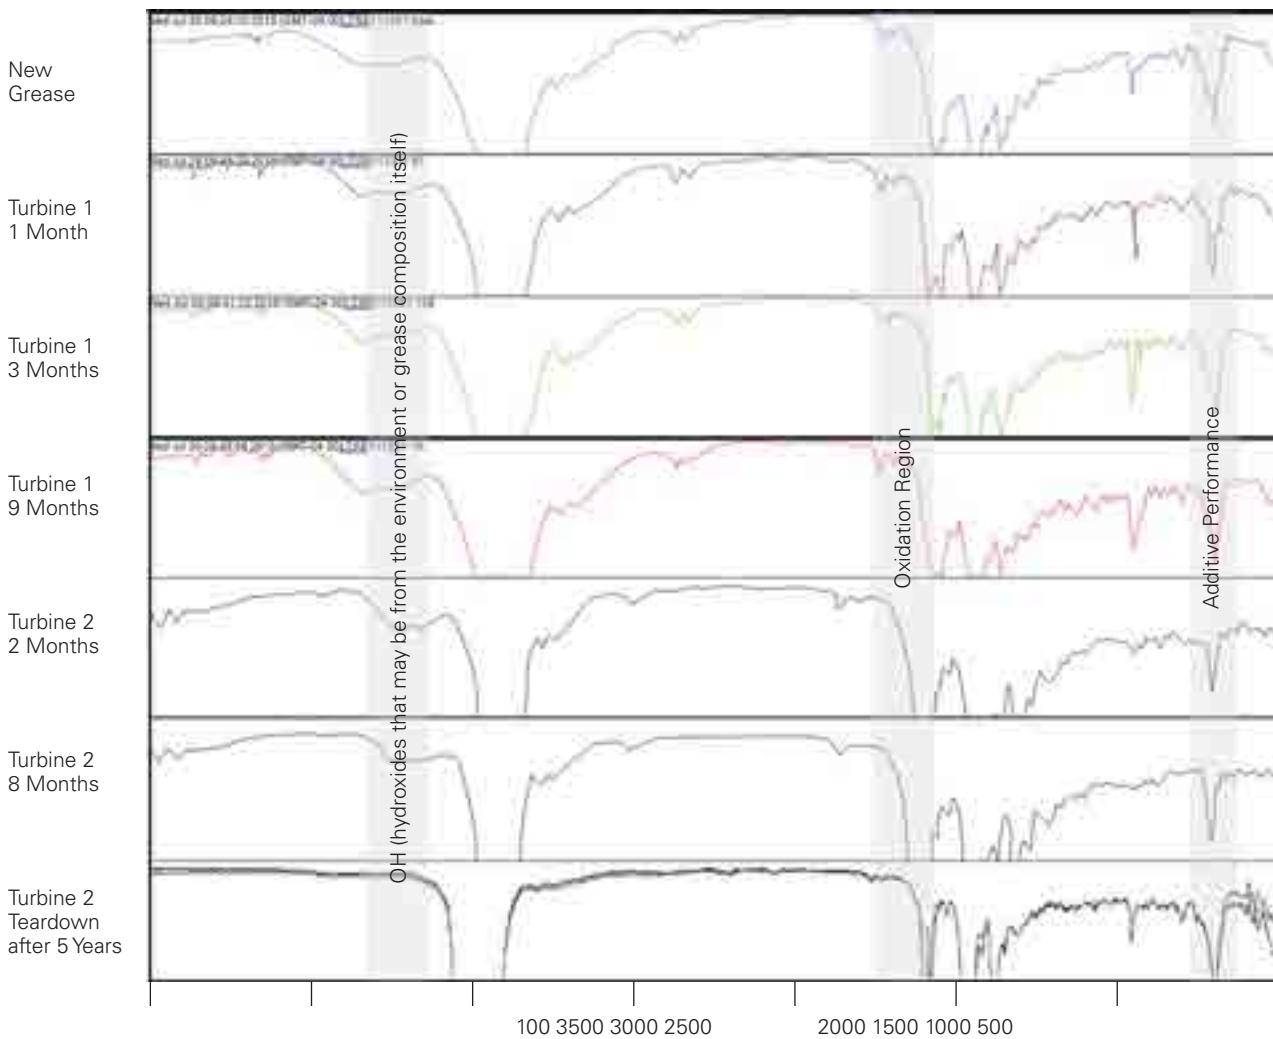
In addition to the above measurements and inspections, grease sampling and analysis conducted at an independent lab evaluated the working condition of the grease. Grease samples were taken periodically in the first nine months of bearing life as well as when the bearing was disassembled. Results for each sample are shown in Figure 30 and Table 4. The periodic grease analysis included:

Figure 30: FTIR Spectrum

FTIR spectrometry shows promising results when comparing the new grease hydroxides, oxidation, and additive performance to that of the turbine grease samples.

There was no significant degradation of the primary grease additives and, overall, the FTIR analysis confirms acceptable grease performance.

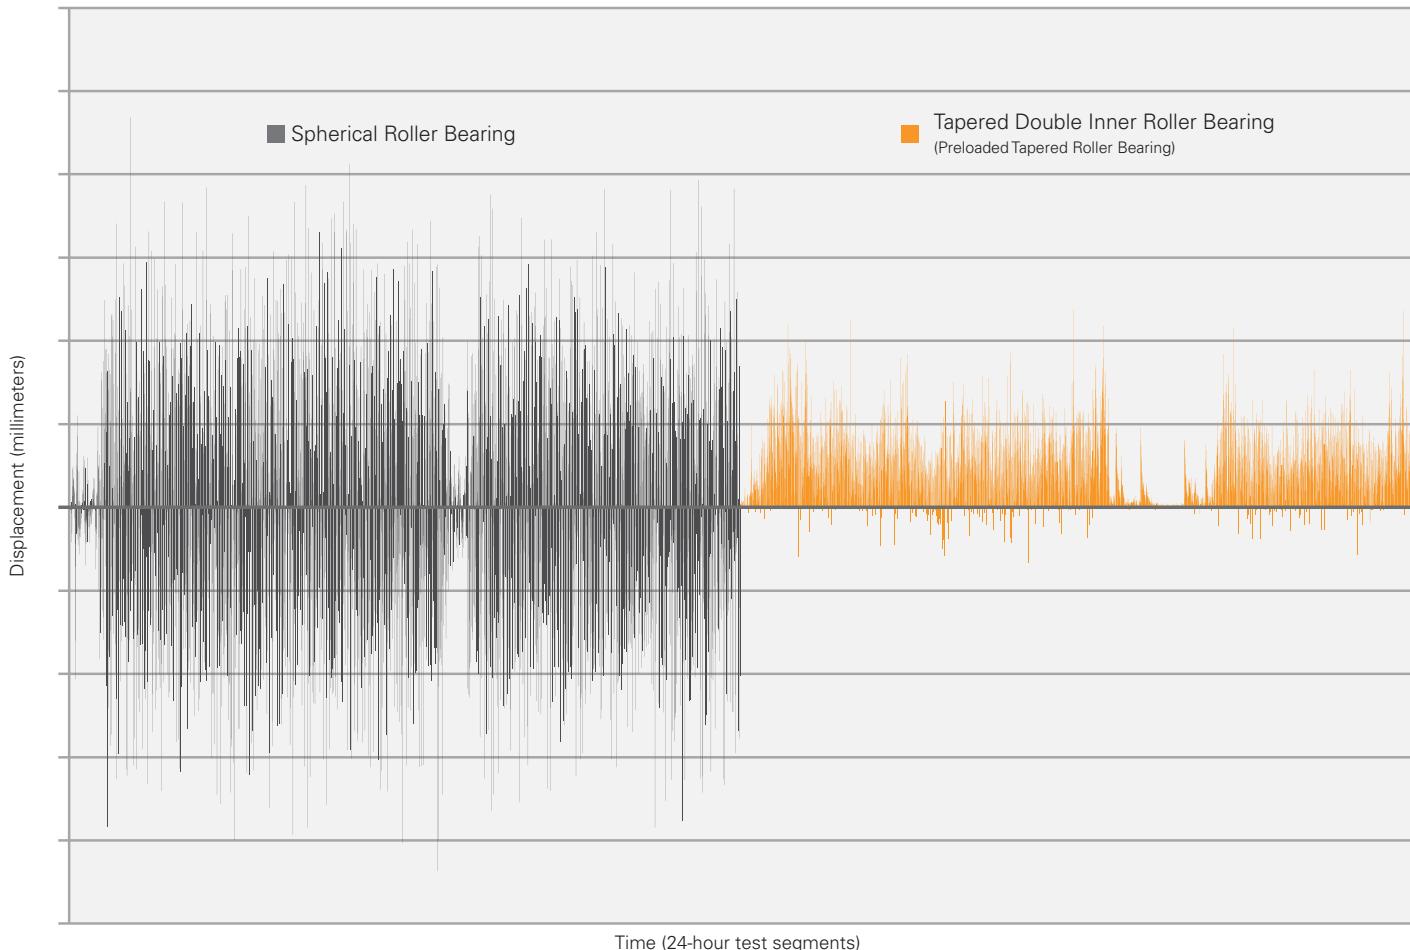
Displacement measurements were taken directly on the mainshaft using sensors mounted with a magnetic base directly on the bedplate. To understand the axial displacement of the shaft on the main bearing and gearbox connection, the results in Figure 31 clearly demonstrate that the displacement of the TDI is approximately one-third that of an SRB.

Directly attributed to the running internal clearance of an SRB versus the mounted preload of the TDI, the preloaded tapered bearing minimizes the transmittal of additional shaft deflection to the gearbox, through the carrier bearings, and to the torque arms. This ultimately should yield improved gearbox performance and reliability.

Time Series Plot of Main Shaft Axial Displacement

Figure 31: SRB and TDI Axial Displacement Comparison

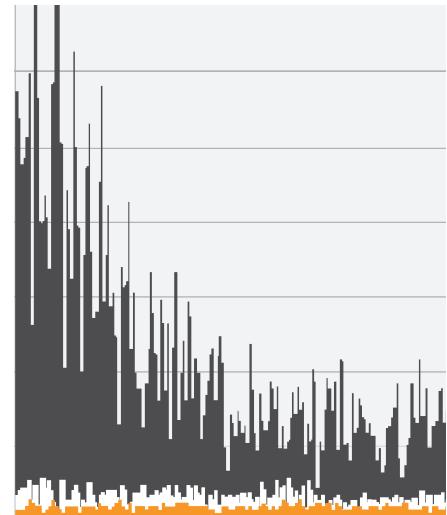
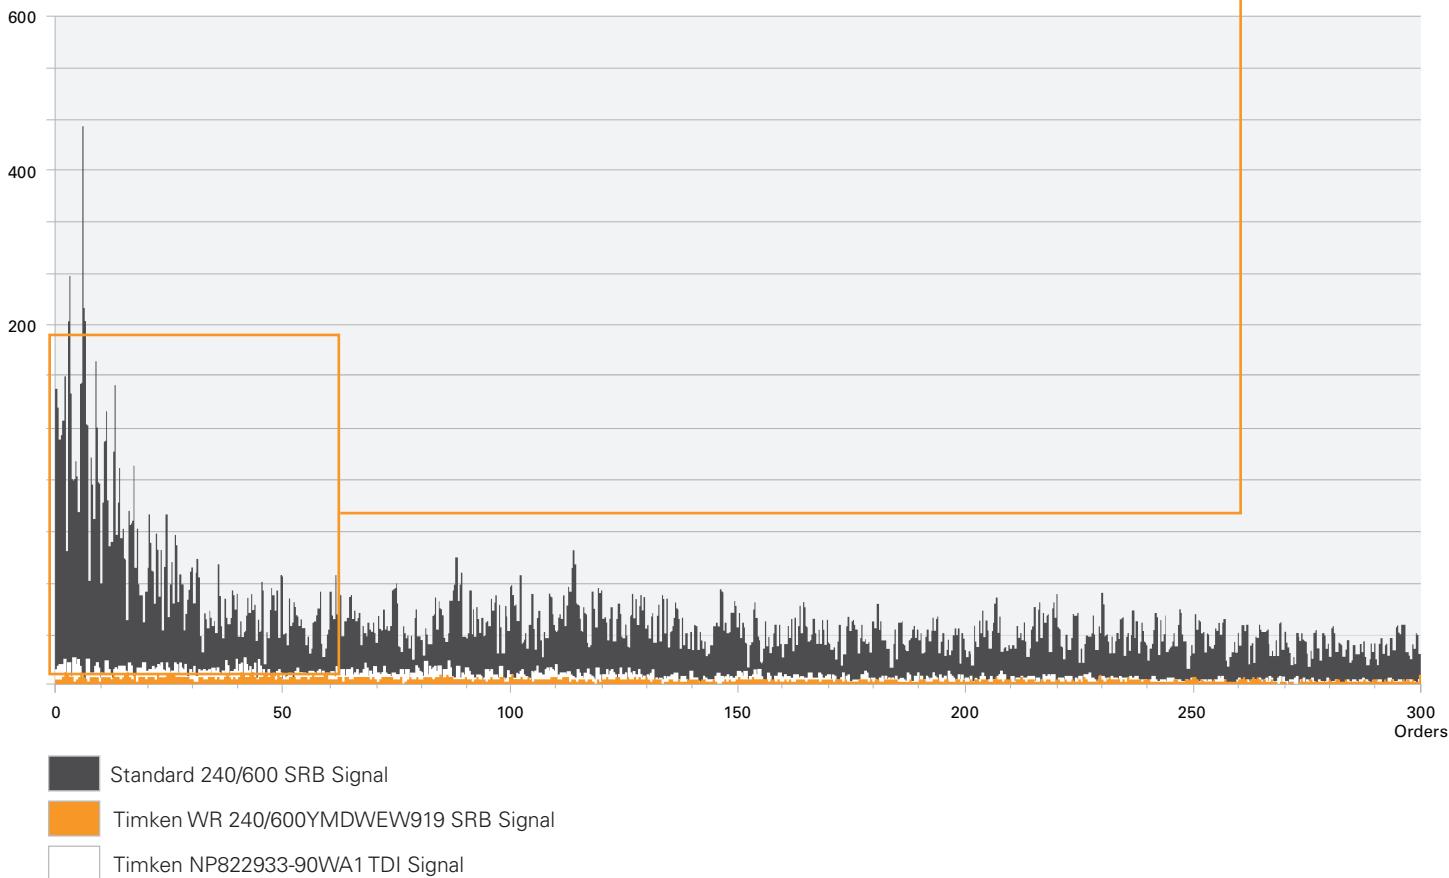
Shock pulse technology is a variant of vibration analysis using an enveloping technique acquired through a tuned transducer. It allows for condition monitoring of slow rotating components and is well suited for mainshaft bearing applications. Shock pulse levels also reflect the amount of metal-to-metal contact in a bearing as it relates to adhesion, micropitting, and early spall detection.

For perspective, Figure 32 represents the shock pulse measurement of a standard OE 240/600 SRB, Timken's WR 240/600YMDWEW919 SRB, and NP822933-90WA1 TDI, respectively. This carpet plot displays the significantly lower shock pulse level of the WR SRB. Comparatively, Timken TDI bearings run at lower shock pulse levels than a standard OE SRB, but at higher levels than the Timken® Wear-Resistant SRB. Figure 32 represent bearings with six months to one year of runtime.

Figure 32: Shock Pulse Values
