## Seal Damage Analysis and Troubleshooting

# TROUBLESHOOTING GUIDE

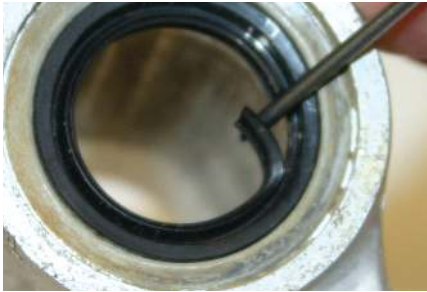
## TORN SEAL LIP

- Damage may have been caused by improper assembly of related parts or the use of improper installation tools.
- Confirm that the seal was guarded by a seal protector when installed over splines, keyways or snap ring grooves.
- Make sure that proper installation tools and methods were used.
- Damage can result from debris contacting the seal lip during operating conditions, which may be too severe for the type of seal being used.

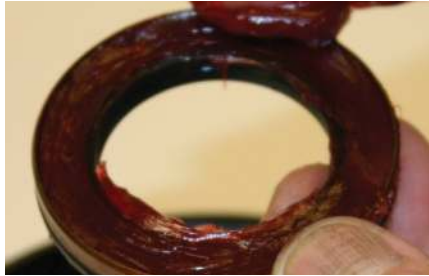
### EXCESSIVE PRELUBRICATION

- Excessive prelubrication is not leakage. When too much prelubricant is used, the excess melts and runs out. Verify this possibility before removing a seal that appears to be leaking.

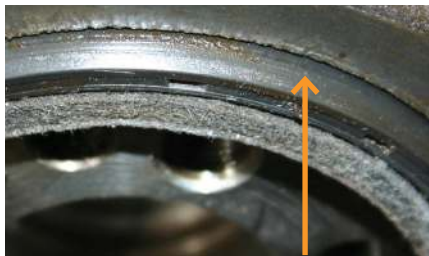
### SEAL FALLING OUT OF THE BORE

- Check the sizes of the bore and the seal. The bore may be too big or the seal may be too small.
