# **Tapered Roller Bearing Rib-Roller End Scoring Damage in Aircraft Landing Wheels**

## Tapered Roller Bearing Rib-Roller End Scoring Damage in Aircraft Landing Wheels

This technical paper explains the risks and root causes for rib-roller end scoring damage to aircraft landing wheel tapered roller bearings. It explains rib-roller end scoring damage, how to identify it and prevention strategies. The paper also discusses the results of Timken application testing that associated loss of grease and high preloads settings with scoring damage risk.

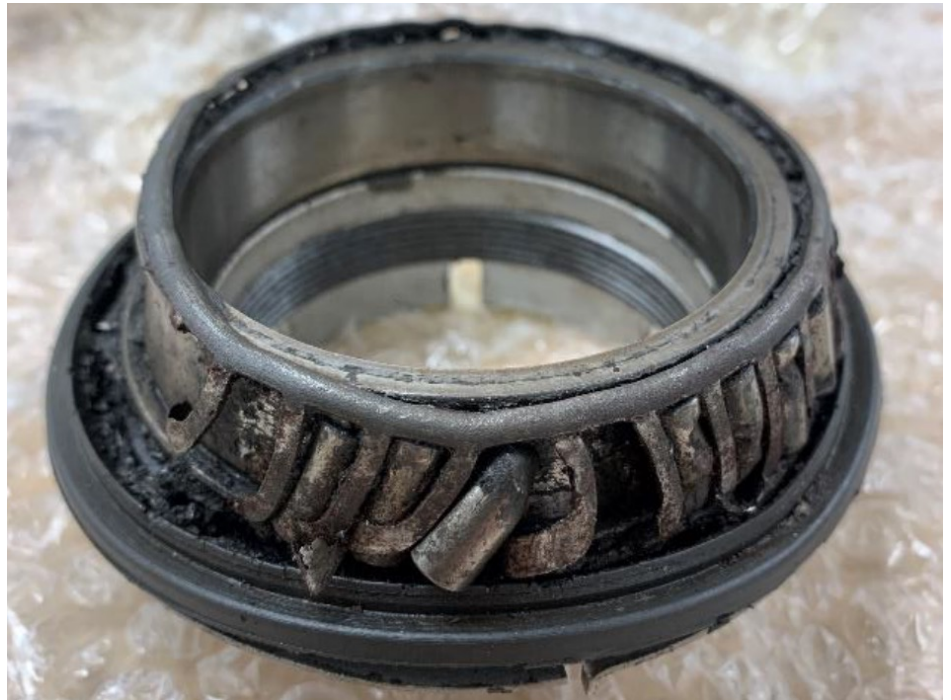
Integration of these special bearing features with a robust wheel and brake inspection and maintenance program are two critical elements for early detection of scoring damage and removal of damaged cone assemblies from service to ensure safe operation. Scored roller ends (explained in more detail later in this document) generate friction and heat, increasing operating temperatures that can result in grease degradation, system debris, and accelerated secondary bearing damage modes. If not properly identified during preventative maintenance, extended service could result in system damage and eventually result in the bearings to lock up.

Locked Up Tapered Roller Bearing Cone Assembly

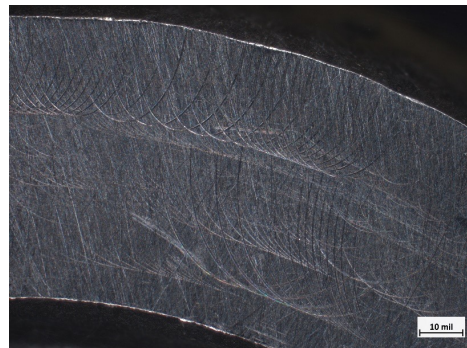
Scoring can be difficult to identify because the early indications can be subtle and varied in appearance. Here are some images of roller ends with scoring damage. Note that the scoring damage can progress slowly, resulting in various appearances depending on the severity of the damage. Scoring damage initially appears as fishhook-shaped scratches and progresses to the heavily scuffed appearance seen on the roller end on the right.

Fishhook Scratches

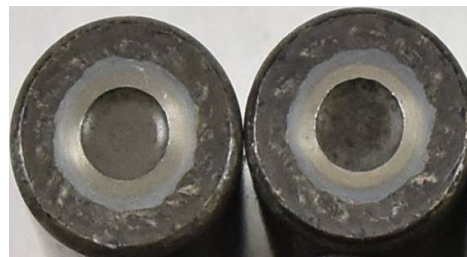
Severe Roller End Scoring Damage
