# Improving Bearing Life in Wind Turbine Mainshafts

**Zachary Broadbent**  
Application Engineer – Wind

In March 2011, the first Timken 230/600 Wear-Resistant SRB with Diamond Like Carbon (DLC) coatings on the rollers was installed into a GE 1.5MW turbine at a wind farm in New Mexico. Since its installation, the bearing was inspected twice, and the bearing was determined to be in good condition each time. With only light debris damage and no visible issues, the bearing remained in service. In 2018 this bearing was removed after seven years of service as the turbine was taken offline for non-bearing related issues. The bearing was then inspected by Timken following its return.

Similarly, a 230/600 Wear-Resistant SRB was removed from another turbine as part of a repower project following a service life of over 10 years. This SRB was installed in March of 2011 at a wind farm in Oklahoma and was removed from service in early 2021. This bearing also underwent in-service inspections in 2015 and 2017, and then a final detailed inspection in 2021 following its removal from service. The positive results of both post operation inspections are detailed below, demonstrating the benefit of t

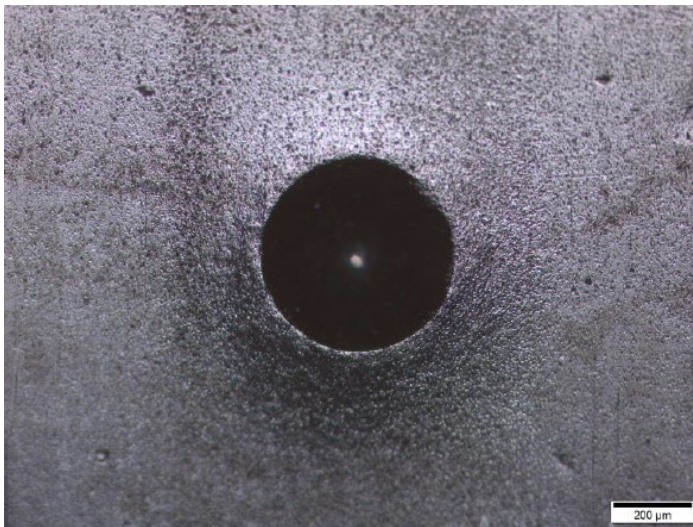
**Figure 10:** Benz Test Indentation

To inspect the rollers, a best case and worst-case roller based on visual appearance was selected from each row resulting in four rollers in total. In addition to a visual inspection, the coatings underwent the Daimler-Benz Adhesion Judgment Scale which is a standard test for analyzing coating adhesion. The test creates an indentation in the coated surface, then analyzes for cracking or delamination of the coating around the indentation.

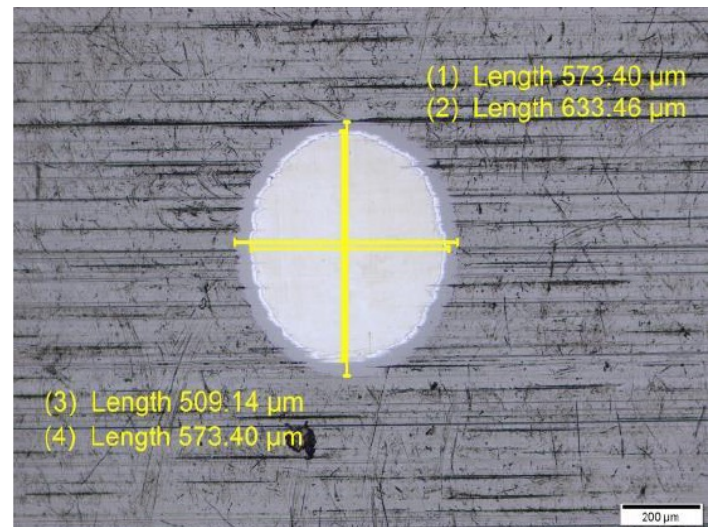
**Figure 11:** Calowear wear scar example

These coatings also underwent the Calowear thickness test, where a ball of a known diameter is used to make a wear scar on the coating with an abrasive solution. The diameter of this wear scar is then measured to determine coating thickness.

Measured Coating Thickness	
Best Case Upwind (Upwind 17)	0.97 μm
Worst Case Upwind (Upwind 23)	1.10 μm
Best Case Downwind (Downwind 17)	0.94 μm
Worst Case Downwind (Downwind 4)	0.96 μm

**Table 6:** Post-operation DLC coating thickness per Calowear test

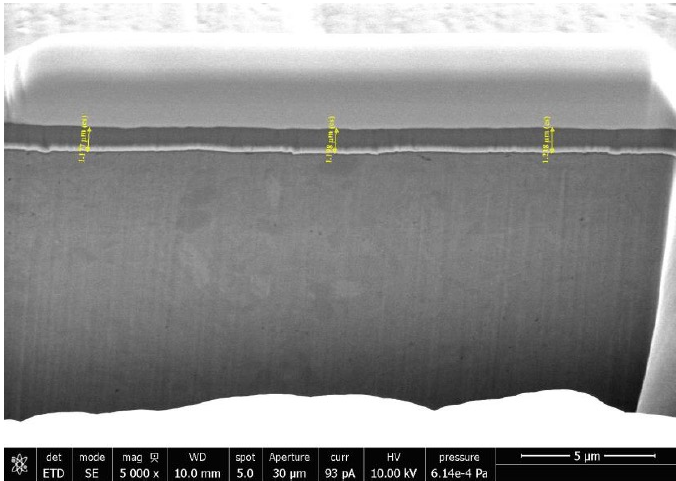
Figure 12: SEM measured FIB section

Coating thickness was also measured by SEM using Focused Ion Beam Milling where material is removed perpendicular to the surface to show a cross section. Both inspections showed no discernable wear of the coating itself. A magnetic particle inspection was also performed that showed no indication of cracks on any of the rollers.

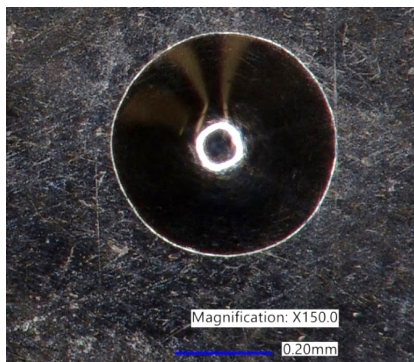
Figure 19: Benz Test Indentation

The DLC coated rollers underwent a full coating inspection including a Benz Adhesion test, Calowear Thickness test, and an SEM thickness measurement. The Daimler-Benz Test is performed by denting the roller with a spherical probe of a known diameter to check for any cracks or delamination under extreme deformation. Calowear test involves using a ball of known diameter and an abrasive media to create a wear scar from which a coating thickness can be measured. The results of these tests indicate that even the worst condition rollers from each row passed all inspections, and the coatings are considered to still be in spec.

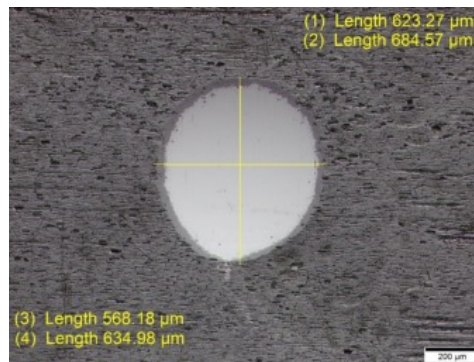
Figure 20: Calowear wear scar example

Measured Coating Thickness	
Best Case Upwind	1.25 µm
Worst Case Upwind	1.01 µm
Best Case Downwind	1.39 µm
Worst Case Downwind	0.79 µm

Table 11: Post-operation DLC coating thickness per Calowear test

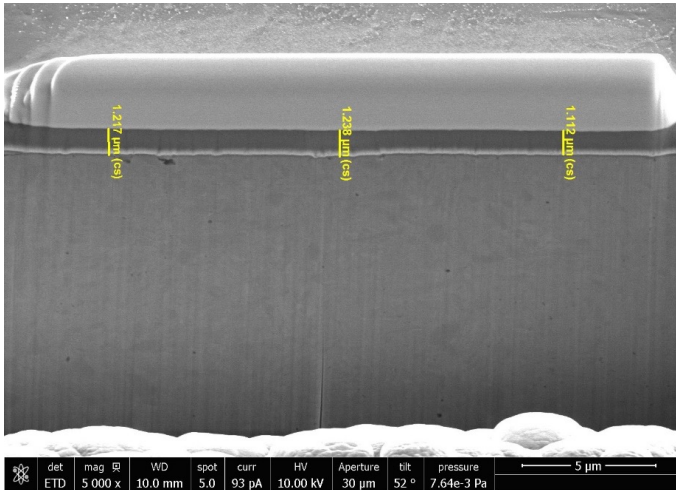
**Figure 21:** SEM measured FIB section

Coating thickness was also measured by SEM using Focused Ion Beam Milling where material is removed perpendicular to the surface to show a cross section. Both inspections showed no discernable wear of the coating itself. A magnetic particle inspection was also performed that showed no indication of cracks on any of the rollers.
