## Wheel Hub Damage Analysis Guide

To diagnose the cause of bearing damage, look closely at damaged hubs and compare customers' hubs with the photos below.

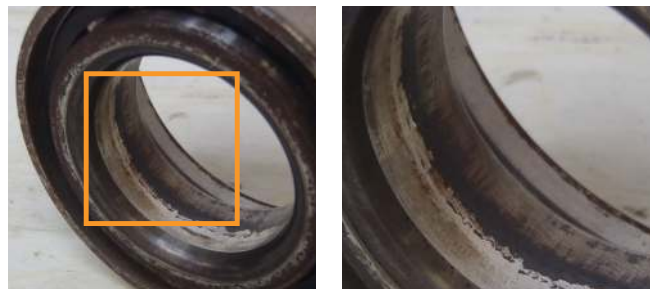
**Diagnosis:** Inspect the hub barrel when replacing a wheel bearing with a separate hub. Check the hub barrel outer diameter (OD) for signs of damage. Look for ridges or discoloration on the barrel surface due to heat damage from cone turning. Replace the hub if you find any signs of damage.

**Cause:** Loss of axle retention or reinstalling a worn hub can allow the cone or inner race to spin on the hub, accelerating wear on the cone bore and hub barrel. This cone turning can indicate loss of bearing retention or improper fit between the cone bore and hub barrel diameter.

Reduce excessive wear by using hubs in good condition.

**Solution:** If you see damage to the hub barrel, replace it.

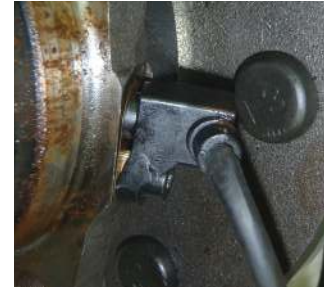
**Diagnosis:** Look for damage from sharp objects or evidence that the cable was caught in a pinch point. Ensure the cable is routed through the entire sensor cable retaining clip. If the sensor cable is not damaged, examine the external sensor for cracks in the sensor body or a loose cable in the sensor head.

Avoid pinched cable by using retainer clips.

**Cause:** Sharp objects may have damaged, pinched or bent the sensor cable. Sensor cable damage is a common cause of ABS malfunctions. Installation may have damaged the wheel speed sensor.

**Solution:** Route sensor cable through all retaining clips. Use hubs in good condition to reduce wear. Avoid pinched cable by using retainer clips.
