Identifying Wheel End Problems

Regular inspection and maintenance can reduce bearing damage in conventional wheel ends and decrease long-term costs.

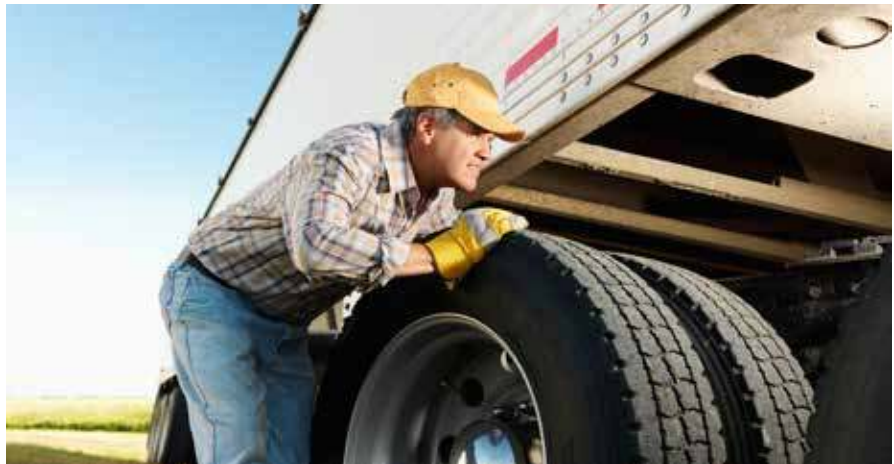
Visual Wheel Inspection

Bearing damage indicators:

- Hubcap sight glass discolored or burnt
- Low lube level in hubcap sight glass
- Lube leakage on wheel hub or tire, inboard and outboard sides
- Abnormal tire wear
- Smoking or extremely hot hubcap

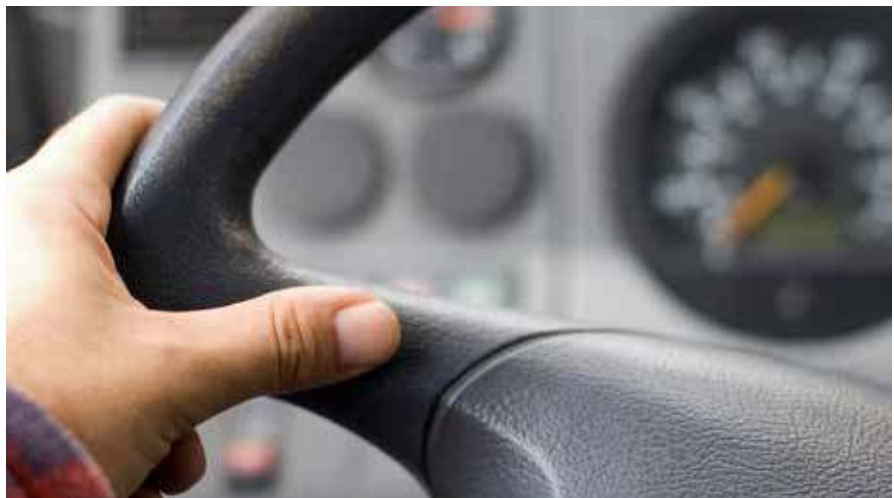
Driver Observations

Bearing damage indicators:

- Wheel vibration
- Wheel wobble
- Wheel noise
- Smoke from a wheel end
- Decreased braking power
- Increased fuel consumption
- Abnormal side pull when braking
- Wheel lock-up/skidding

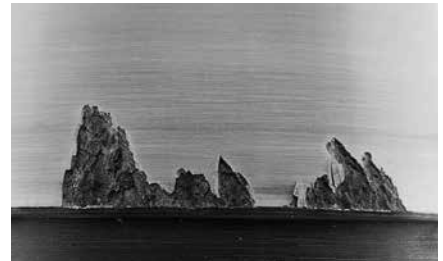
Fig. 2: Geometric Stress Concentration (GSC) spalling

- Dry, caked lube in hubcaps or other internal cavity
- Metal particles in lube, hubcaps, hubs, or bearings
- Heat discoloration on bearings or any other internal component (heat discoloration is a nonremovable stain)
- Grooves on bearing cone (inner race) backface, bore or spindle
- Wear on any bearing surface
- Dents on bearing assembly cage
- Spalling (flaking away) of bearing material on races or roller bodies (Fig. 1 and 2)
- Any raised metal or dents on races or rollers
