Identifying Wheel End Problems

Regular inspection and maintenance can reduce bearing damage in conventional wheel ends and decrease long-term costs.

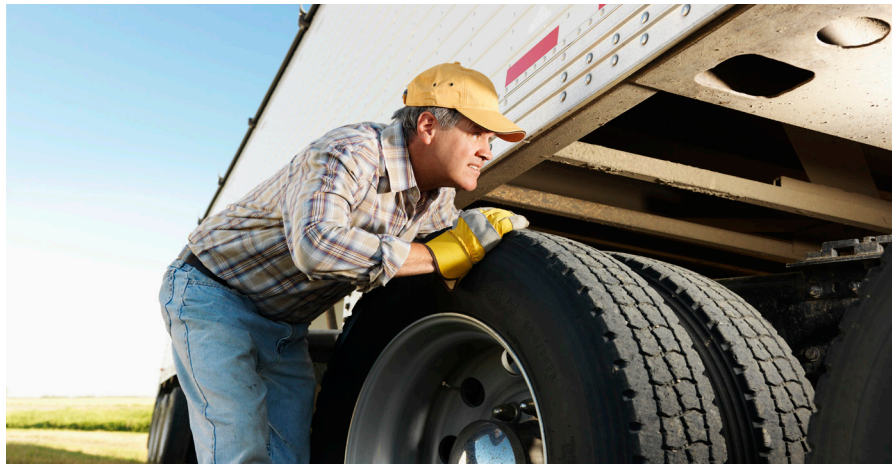
Visual Wheel Inspection

Bearing damage indicators:

- Hubcap sight glass discolored or burnt
- Low lube level in hubcap sight glass
- Lube leakage on wheel hub or tire, inboard and outboard sides
- Abnormal tire wear
- Smoking or extremely hot hubcap

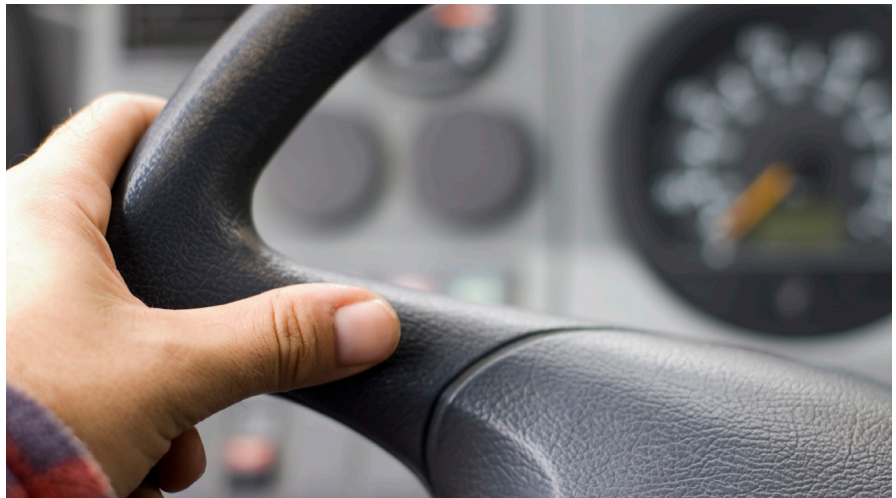
Driver Observations

Bearing damage indicators:

- Wheel vibration
- Wheel wobble
- Wheel noise
- Smoke from a wheel end
- Decreased braking power
- Increased fuel consumption
- Abnormal side pull when braking
- Wheel lock-up/skidding

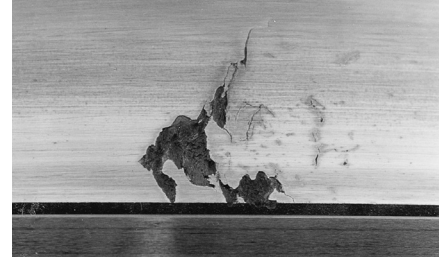
Fig. 1: Point Surface Origin (PSO) spalling

- Dry, caked lube in hubcaps or other internal cavity
- Metal particles in lube, hubcaps, hubs, or bearings
- Heat discoloration on bearings or any other internal component (heat discoloration is a nonremovable stain)
- Grooves on bearing cone (inner race) backface, bore or spindle
- Wear on any bearing surface
- Dents on bearing assembly cage
- Spalling (flaking away) of bearing material on races or roller bodies (Fig. 1 and 2)
- Any raised metal or dents on races or rollers
