## Wheel Hub Damage Analysis Guide

To diagnose the cause of bearing damage, look closely at damaged hubs and compare customers' hubs with the photos below.

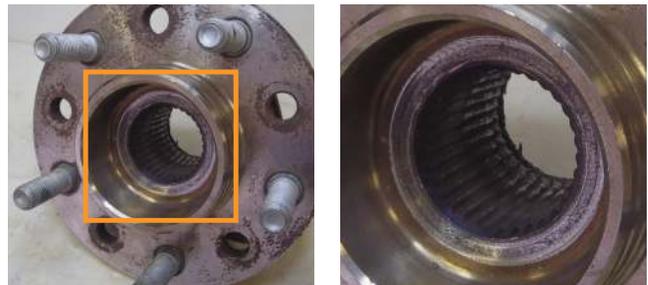
**Diagnosis:** Rough or worn axle retaining nuts indicate movement due to loss of bearing retention. Refer to the original equipment manufacturer's instructions or visit [timkeninfo.com](http://timkeninfo.com) to identify the proper torque for the axle retaining nut.

**Cause:** Loss of bearing retention is the leading cause of hub bearing damage, resulting in wheel vibration and/or noise.

The axle-retaining nut backs off when bearings demonstrate improper torque or have lost their self-retention features. This changes the setting of the bearings inside the hub, causing misalignment and accelerating wear.

Tighten axle lock nut to proper torque to help avoid rough and worn surface under the nut.

**Solution:** Always use a new axle retaining nut and tighten it to the proper torque to avoid a rough and worn surface under the nut.

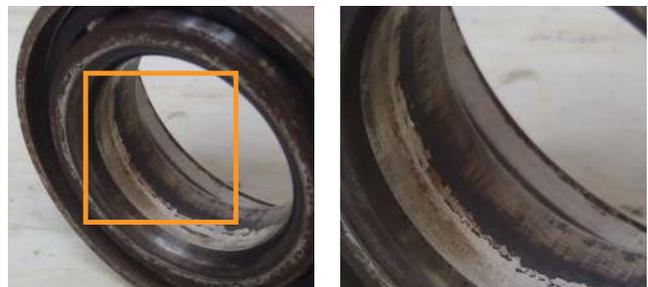
**Diagnosis:** Inspect the hub barrel when replacing a wheel bearing with a separate hub. Check the hub barrel outer diameter (OD) for signs of damage. Look for ridges or discoloration on the barrel surface due to heat damage from cone turning. Replace the hub if you find any signs of damage.

**Cause:** Loss of axle retention or reinstalling a worn hub can allow the cone or inner race to spin on the hub, accelerating wear on the cone bore and hub barrel. This cone turning can indicate loss of bearing retention or improper fit between the cone bore and hub barrel diameter.

Reduce excessive wear by using hubs in good condition.

**Solution:** If you see damage to the hub barrel, replace it.

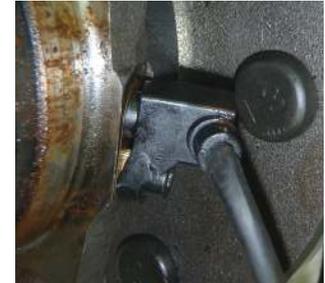
**Diagnosis:** Look for damage from sharp objects or evidence that the cable was caught in a pinch point. Ensure the cable is routed through the entire sensor cable retaining clip. If the sensor cable is not damaged, examine the external sensor for cracks in the sensor body or a loose cable in the sensor head.

Avoid pinched cable by using retainer clips.

**Cause:** Sharp objects may have damaged, pinched or bent the sensor cable. Sensor cable damage is a common cause of ABS malfunctions. Installation may have damaged the wheel speed sensor.

**Solution:** Route sensor cable through all retaining clips. Use hubs in good condition to reduce wear. Avoid pinched cable by using retainer clips.
